SOUTH JERSEY LEVEE INVENTORY

Levee 13 – Locust Island Levee at Hancocks Bridge, Salem County, New Jersey

November 2010

USDA Natural Resources Conservation Service
Assisting
New Jersey Department of Environmental Protection
Bureau of Dam Safety and Flood Control

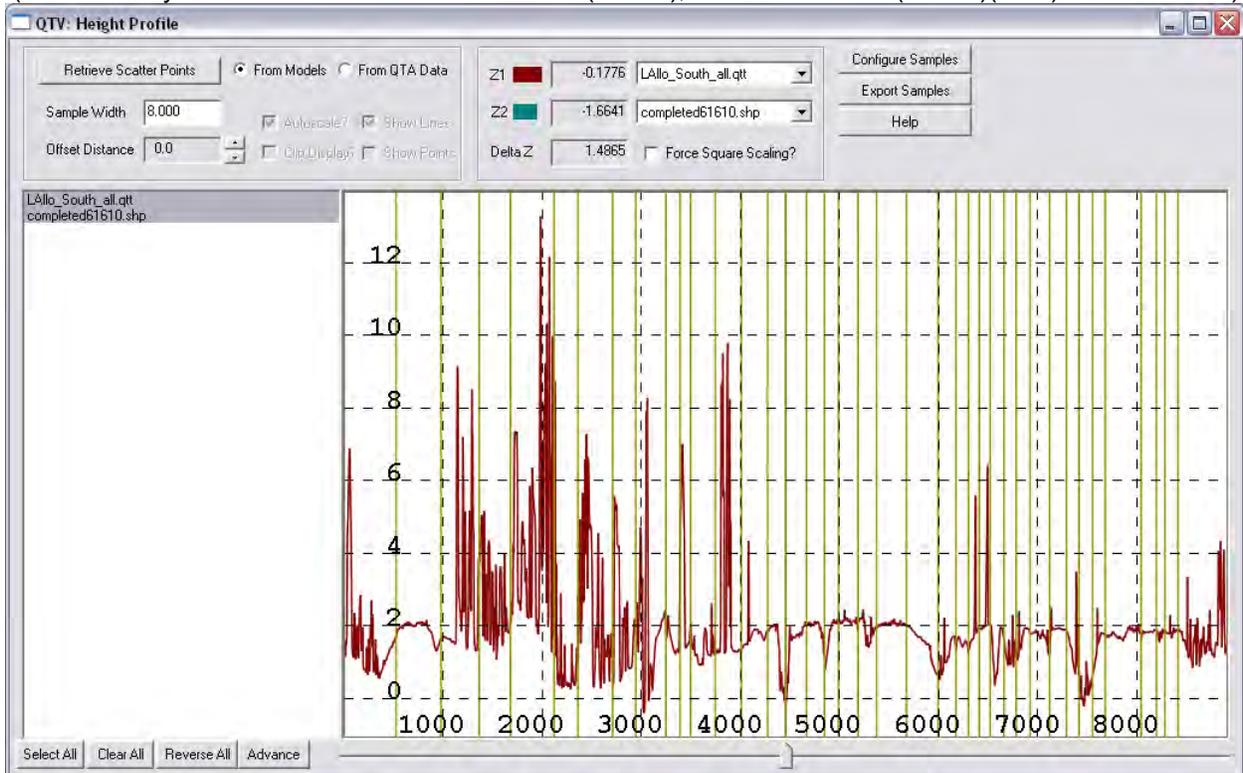
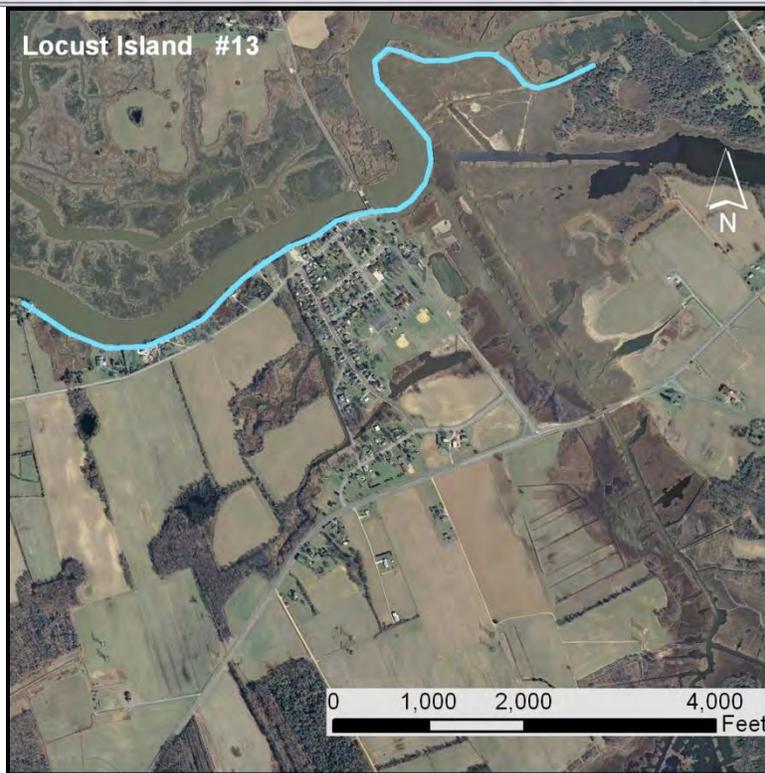
Figure 8- Levee Profile and Overview – Levee #13 Locust Island (Protects Hancock Bridge)

(South Jersey LiDAR data = elevations in meters(Y Axis), Mensuration line (X Axis)(Feet) = west to east)

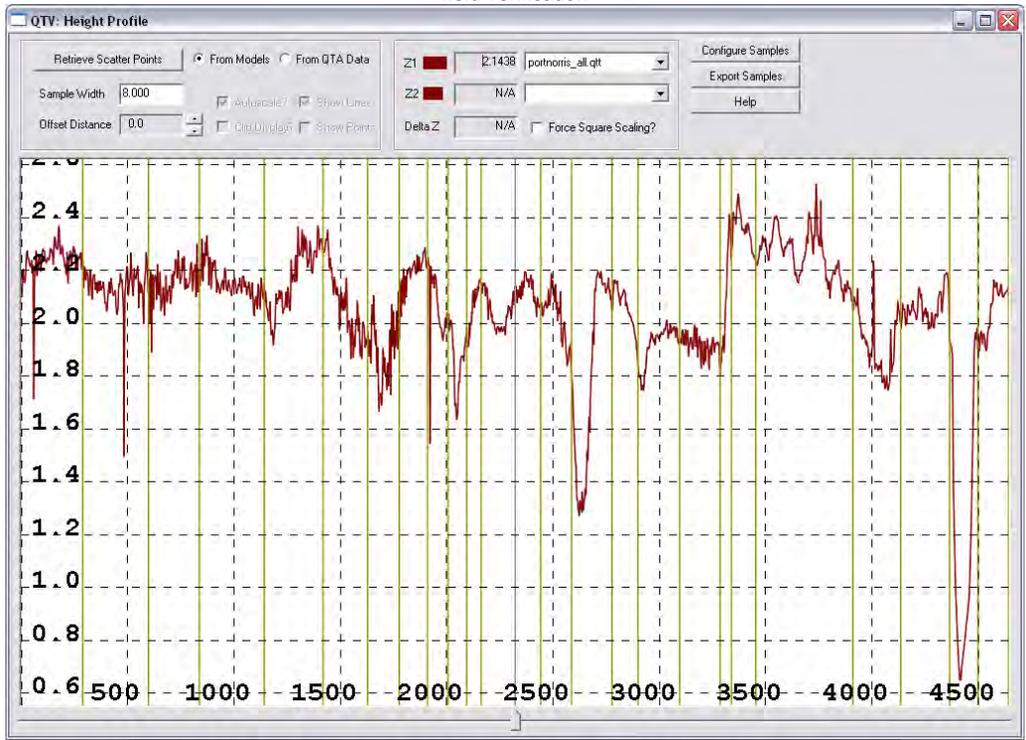
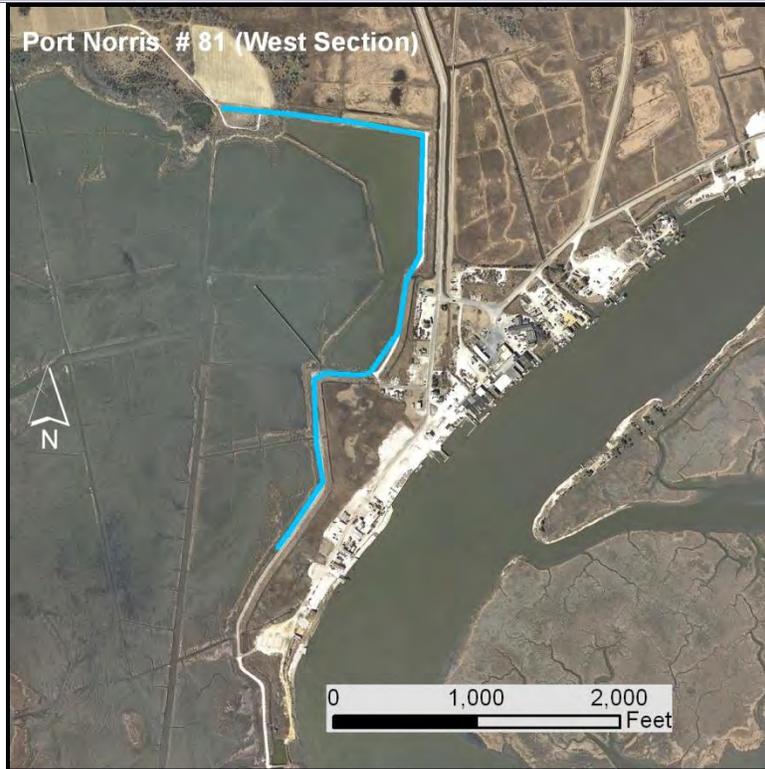
Figure 11- Levee Profile and Overview – Levee #81 Port Norris (West Section)

(South Jersey LiDAR = elevations in meters (Y Axis), Mensuration line (X Axis)(Feet) = north to south)
The low point at 4500 on the graph corresponds to a gap that is visible on the LiDAR Data, however, it was not observed during field verification

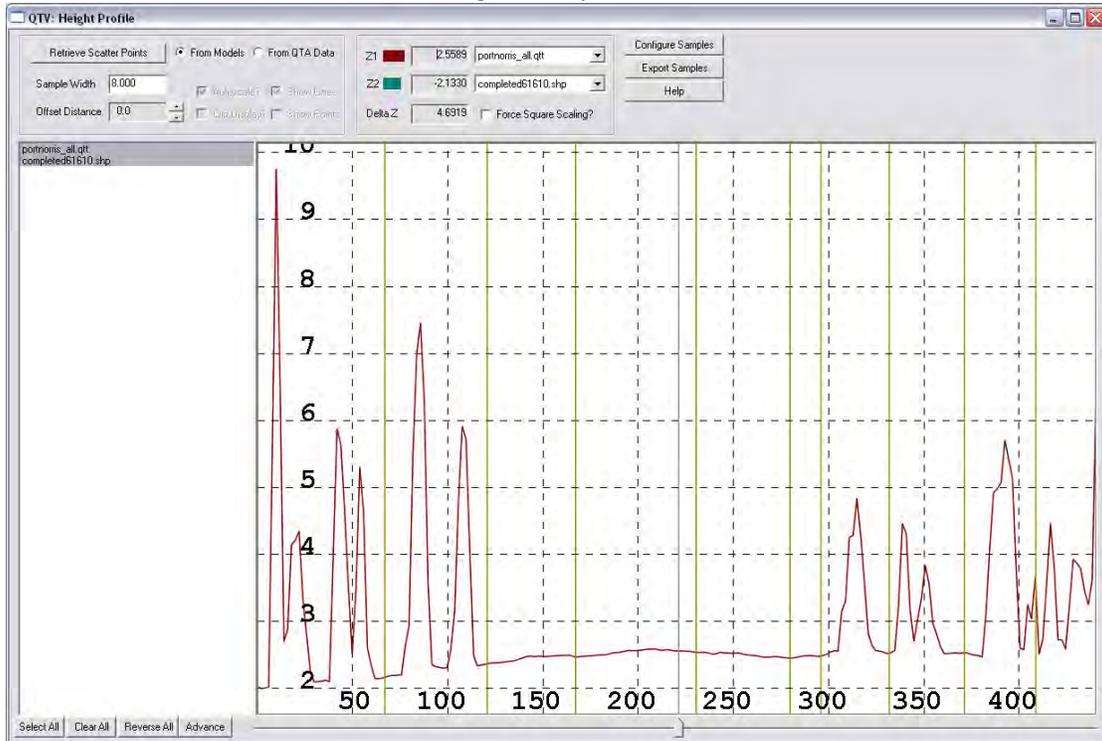
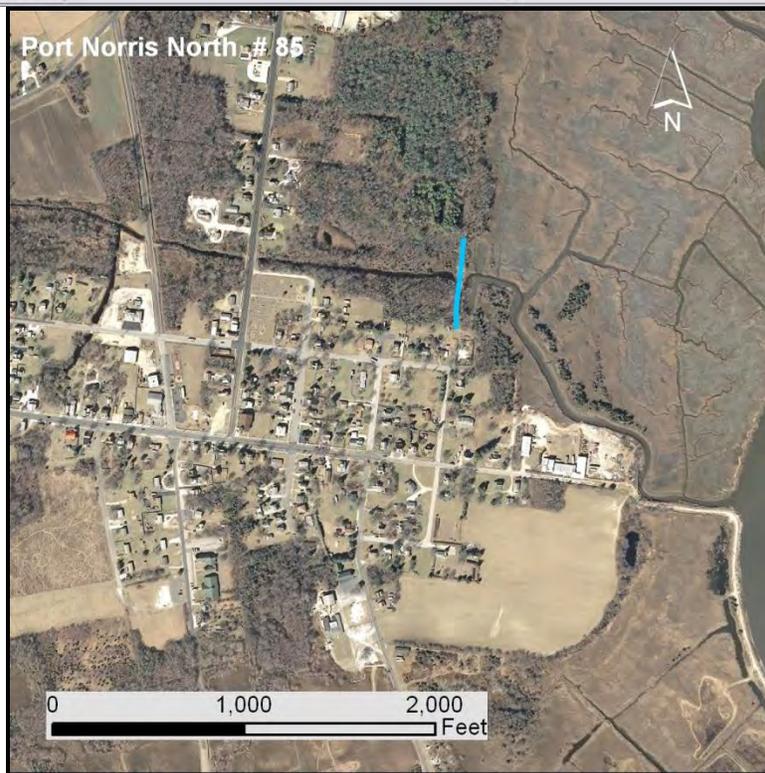
Figure 12- Levee Profile and Overview – Levee #85 Port Norris North
 (South Jersey LiDAR = elevations in meters (Y Axis), Mensuration line (X Axis)(Feet) = north to south)
 There is a lot of tall vegetation proximate to the structure.

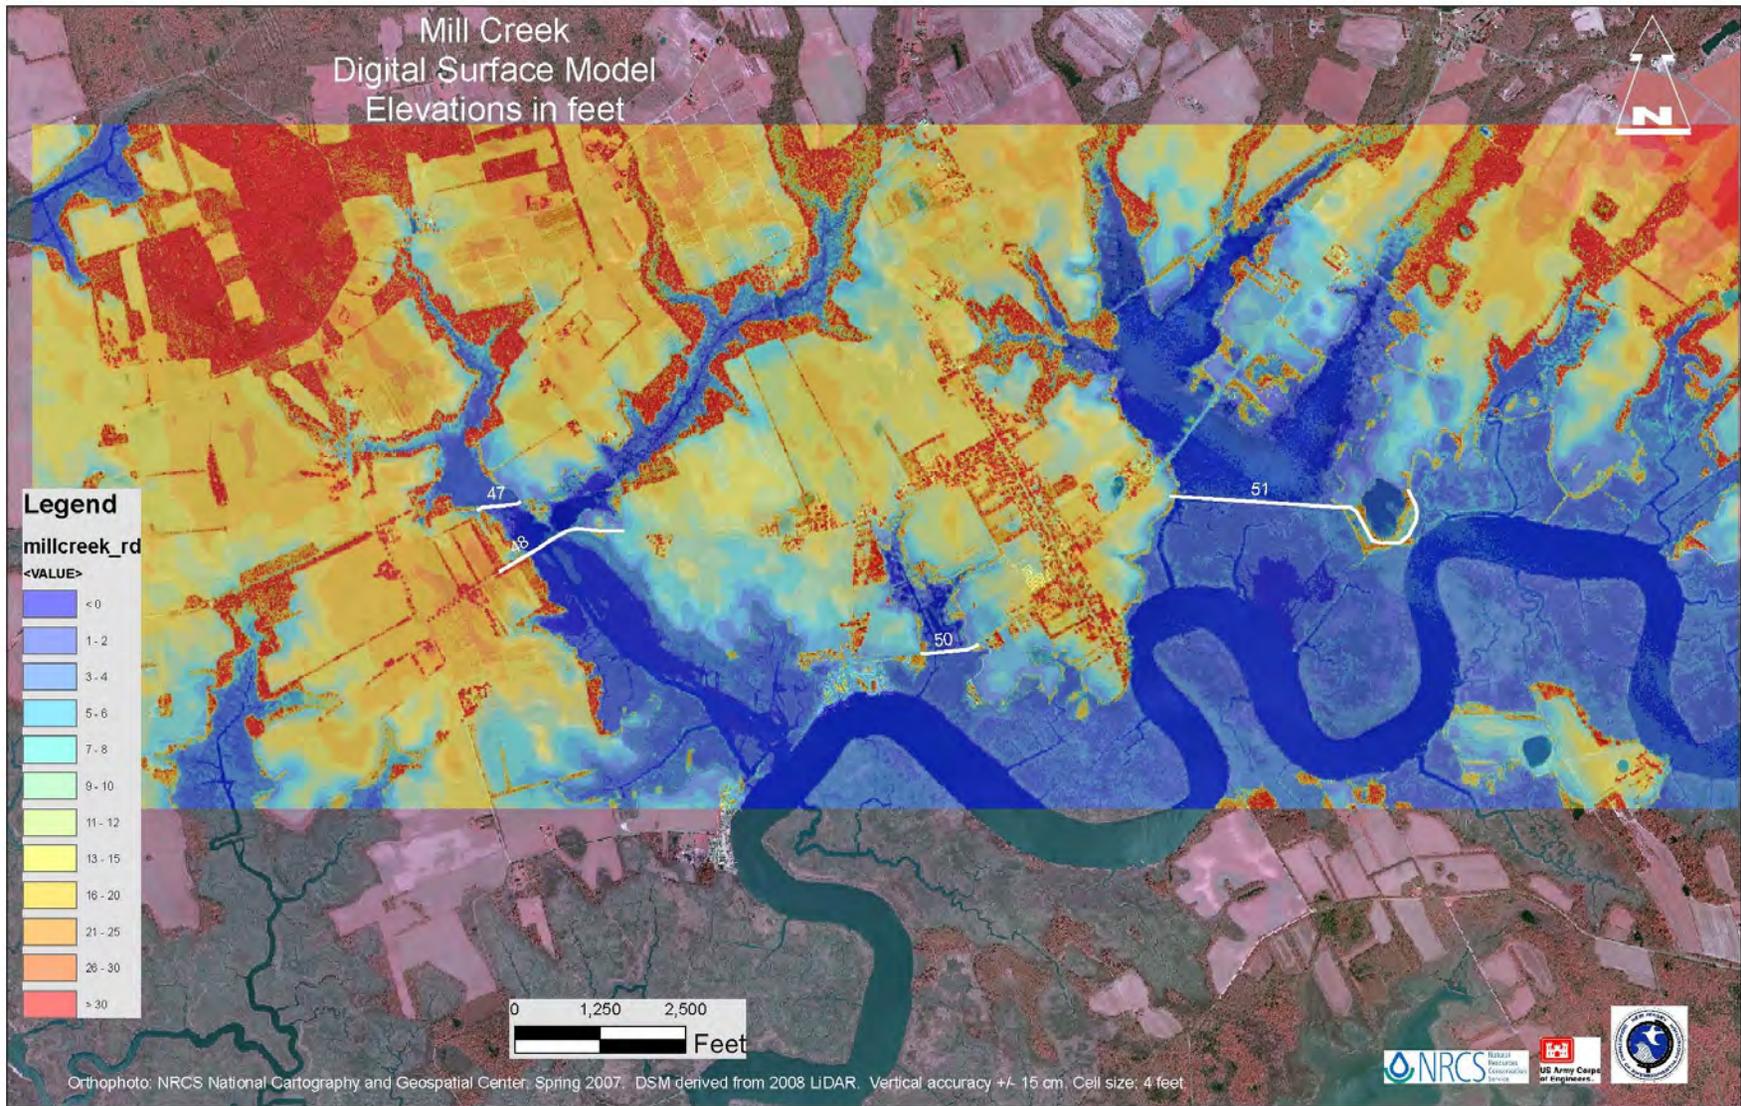
Figure 13 shows elevation of the surface including trees, shrubs and buildings at the Mill Creek Levee (Levee # 51). Elevations that are 8 feet or less are denoted by shades of blue. The areas shown in blue shades are approximately equivalent to the elevation of the top of most levees in South Jersey. Areas at this elevation or less would likely be inundated in the event of levee failure. Major flooding from hurricane or other storm events would exceed the levee heights in most areas of South Jersey.

The FEMA Flood Insurance Study for Greenwich Township shows that the 100 year flood elevation is at 8.8 feet msl. (1929 Datum). The LiDAR representation of this area is consistent with this. A recent NRCS survey of Levee #51, which is in need of a water control structure replacement, shows the elevation of the levee ranges from 9.0 to 9.5 (1929 Datum). FEMA Flood Insurance requirements for a levee require that the levee have a minimum of three (3) feet of freeboard above the 100 year flood elevation (FEMA, 2005). So while the levee has been constructed approximately to the 100 year flood elevation, it does not qualify under FEMA criteria as a flood control structure due to insufficient freeboard. This is similar to other levees in South Jersey where, at best, reliable protection is provided against tidal inundation and low level flood events only.

Figure 16- Mill Creek (Union Bank) Levee (Levee 51), Greenwich Twp., Cumberland County-
An Example of LiDAR-Derived Elevations

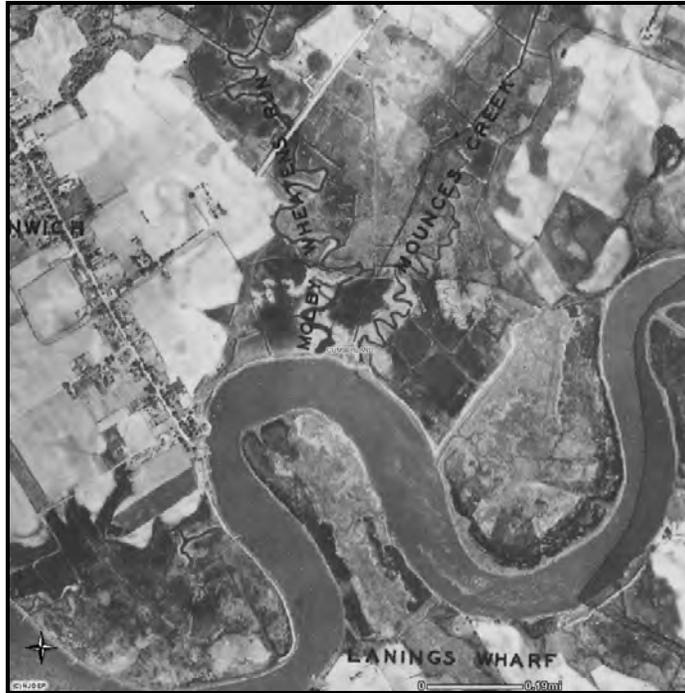
The Mill Creek dike was constructed along the bank of the Cohansey River, from material taken out of the river. It was thus subject to erosive effects of

of wave action and river current, and maintenance was costly. Periodically, high tides, often associated with hurricanes, caused damage to the dike. Storms that damaged or overtopped the dike occurred in August 1933, October 1933, November 1953, August 1955, and May 1960 (USDA SCS, 1962).

Figure 25 – Mill Creek Dike at Greenwich on Cohansey River, Cumberland County – 1930
(Photo Courtesy of NJDEP I-map)

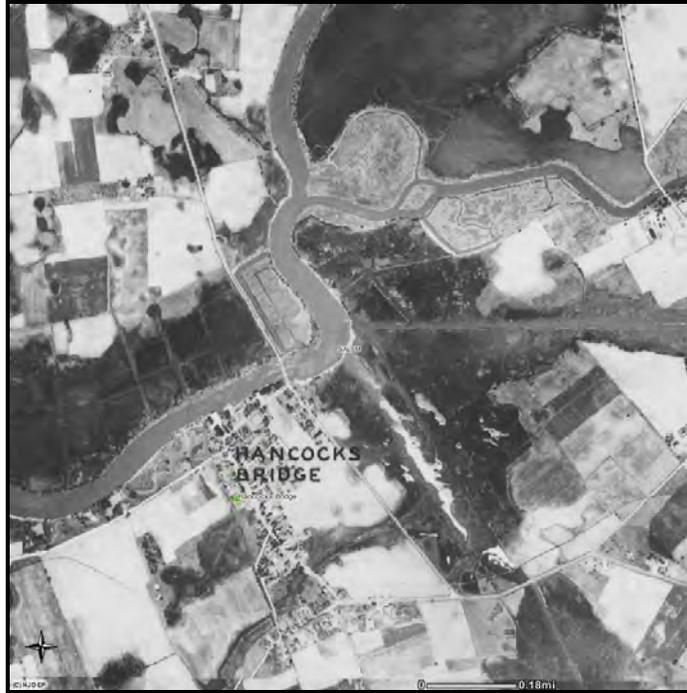
The Locust Island dike was overtopped in September 1940 by excessive Runoff in the Lower Alloways Creek. This runoff was caused by a severe Tropical storm which started on September 1, 1940, with over ten inches of rainfall in twelve hours. The water flooded the entire Silver Lake-Locust Island area. The annual repair costs run between \$300 and \$500 and are in addition to the annual maintenance costs (USDA SCS, 1957).

Figure 29 – Locust Island Levee at Hancock's Bridge, Lower Alloways Creek, Salem County – 1930
(Photo Courtesy of NJDEP I-Map)

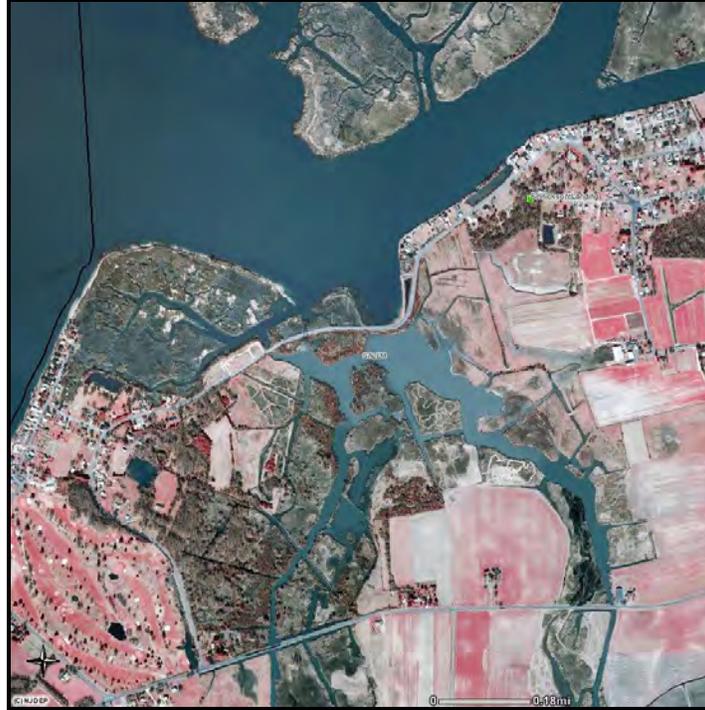
Figure 34 – Middle Neck Levee – Elsinboro Township, Salem County – 2002
(Photo Courtesy of NJDEP I-Map)

Figure 34 shows the Middle Neck dike/levee. Information on its levee history is as follows:

The storm of August 1933 severely breached the dike and clogged drainage channels with sediment and debris. Occurring in the height of the depression era, the Middle Neck Meadow Company could not finance the needed repairs. Salem County repaired the damage, and has since maintained the dike as a county road. The channels have never been adequately repaired and have undergone additional clogging with vegetation since 1933 (USDA SCS, 1964).
