Draft Environmental Assessment for Structure Repairs on the Weber River

Weber County, Utah

July 2013

Title and Document Status: Draft Environmental Assessment (Draft EA) for Structure Repairs on the Weber River

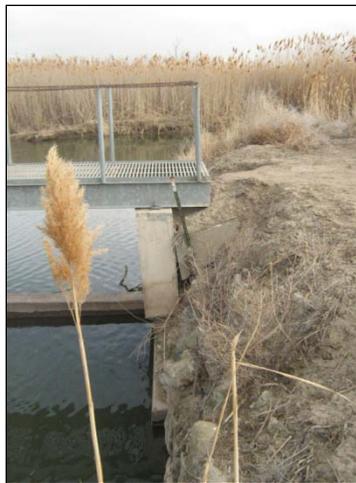
Components of this structure were damaged during the 2011 flood event. Damage to the structure includes erosion around the foundation of the structure and the wingwalls, the radial gates do not seal properly, and the gate support arms are bent making it difficult to operate.

Picture 1-2. North Run Structure Wingwall Erosion

- Remove and replace the existing radial gates with automated radial gates.
 - Each gate would have a supervisory controls and data acquisition (SCADA) system to monitor the structure.
- Install riprap around the foundation of the structure on the banks to prevent further erosion.
- Install a new river gage to track the volume of water flowing through the structure.

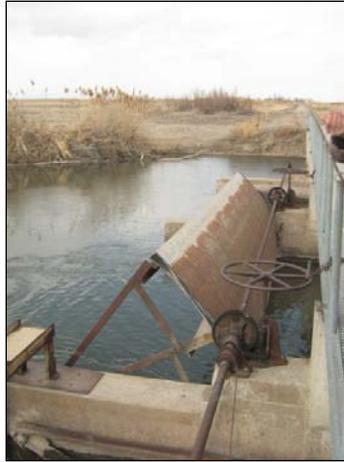
Picture 1-3. North Run Structure Damaged Radial Gate

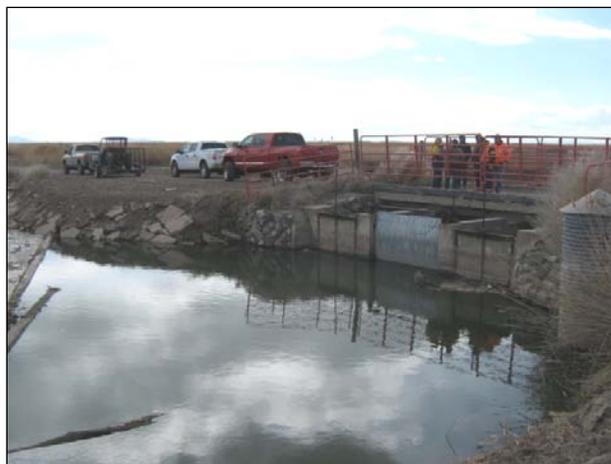
The Middle Run Structure is located in the north center of the Ogden Bay WMA and contains one radial gate and two slide gates to regulate water flowing into Unit 1; a marsh area managed for nesting and foraging habitat for migratory birds which has no direct outlet to the Great Salt Lake. There are numerous small water turnout structures within Unit 1 that regulate small ponds for habitat as discussed in Chapter 1.6.4. These structures are aged and are only capable of withholding or passing small volumes of water (10 to 20 cfs). The radial gate was damaged during the 2011 flood event when the gate was mechanically opened by Ogden Bay WMA staff.

Picture 1-4. Middle Run Structure (Upstream End Looking Southwest)

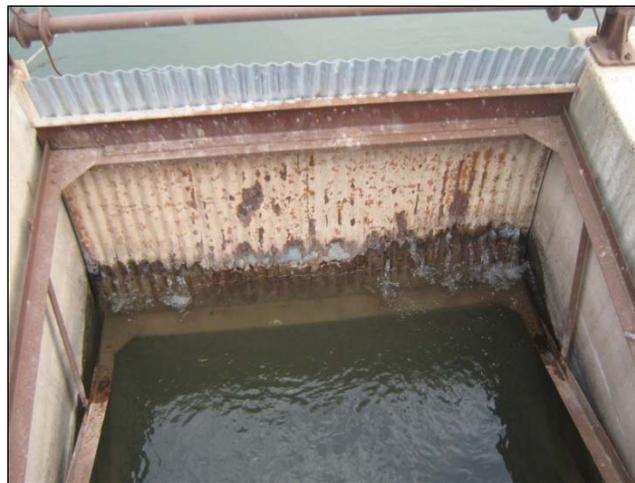
Picture 1-6. Middle Run Structure Leaking Radial Gate

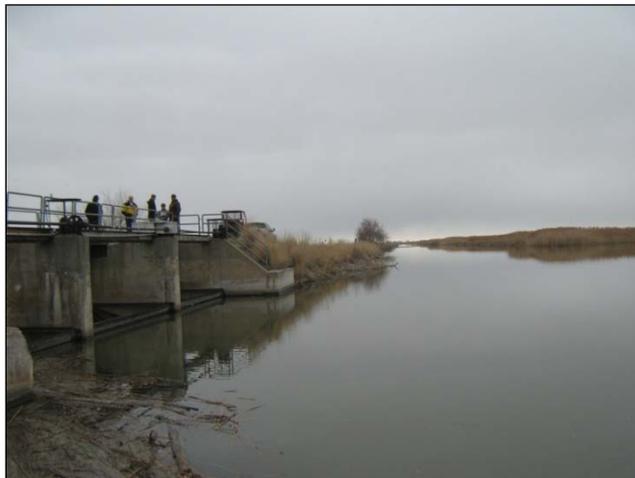
Picture 1-7. South Run Structure (Upstream End Looking North Toward Middle Run)

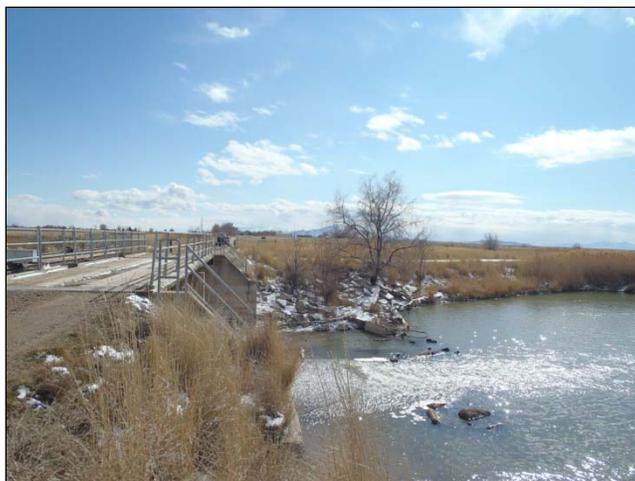
Picture 1-8. South Run Structure (Downstream End Looking South)

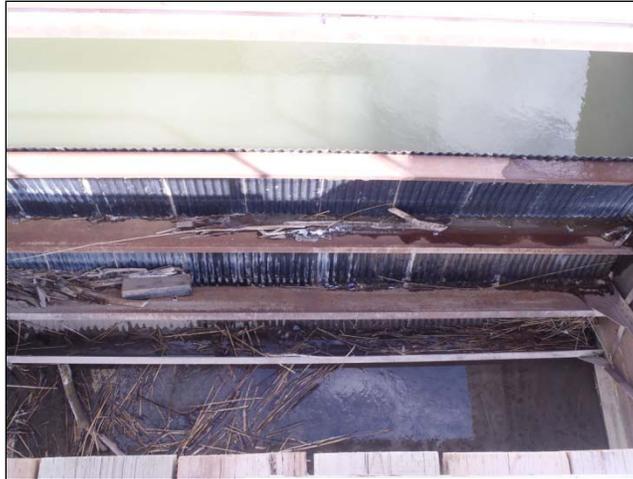
During flood events, the gates on this structure are fully opened and a little more than half of the flood water would be conveyed through the structure. When the gates are raised to the highest level during a flood event, there is generally a significant difference in water surface elevation between the upstream and downstream side of the structure. An 18-inch water surface elevation difference was observed during the 2011 flood event at peak discharge. A wooden deck bridge is located on top of the structure to

Picture 1-9. South Run Structure Radial Gate

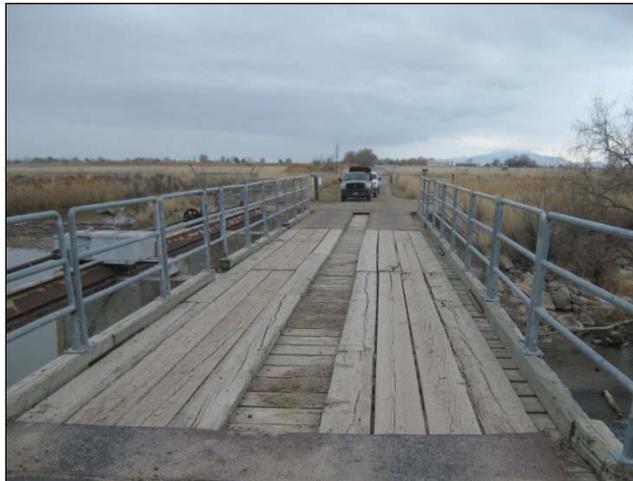
facilitate vehicle and equipment transport, but does not have sufficient load capacity to allow heavy construction equipment travel. This limits the ability of Ogden Bay WMA staff to maintain the refuge and respond to emergency situations during flood events since they have to use smaller construction equipment.

Picture 1-10. South Run Structure Bridge

- Repair/modify the existing water control structure.
 - Replace the wooden deck bridge across the existing structure with a reinforced concrete deck to provide access across the structure for heavy construction equipment.

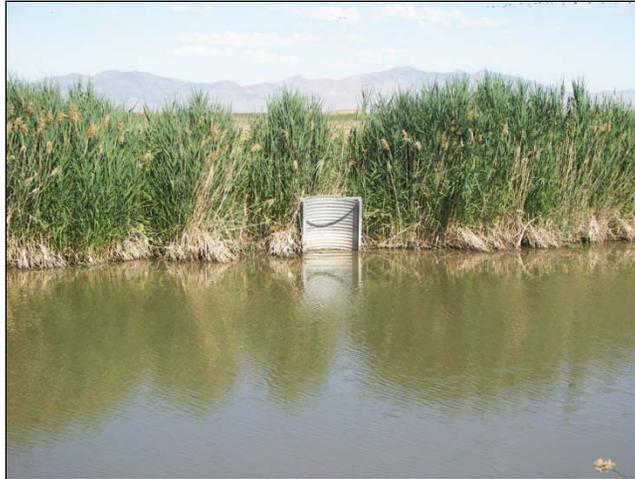
Picture 1-11. Unit 1 Typical Metal Water Turnout Structure

- Replace eight water turnout structures.
- Repair approximately 2,200 feet of low spots in the levee.

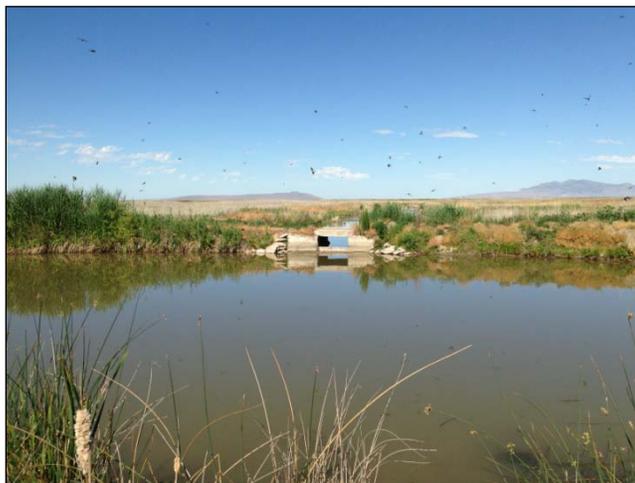
Picture 1-12. Unit 1 Typical Concrete Water Turnout Structure

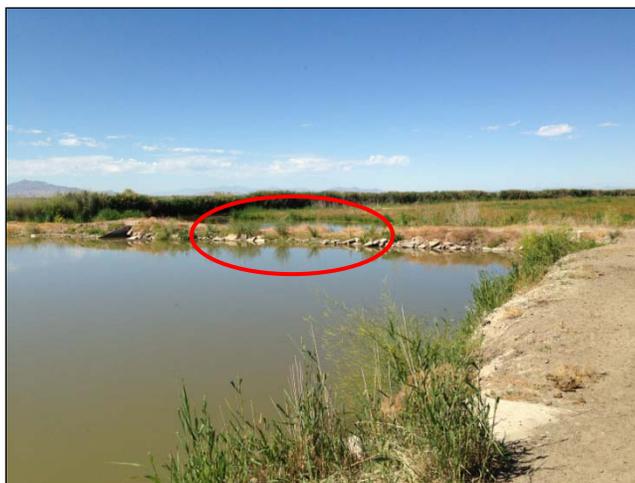
Picture 1-13. Unit 1 Typical Low Spot in Levee

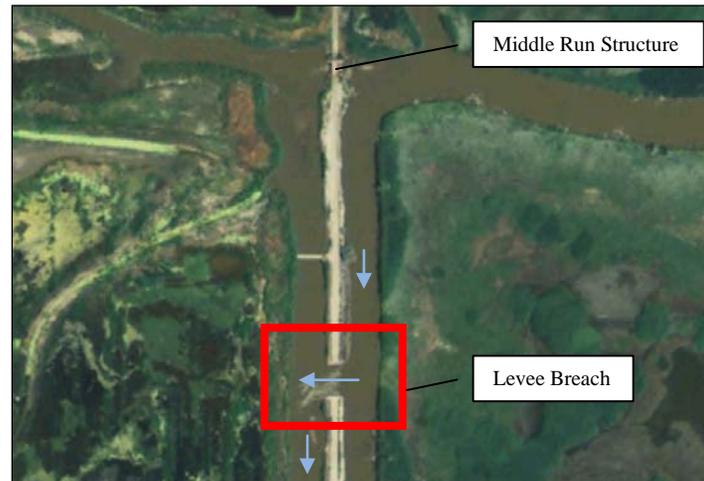
During the 2011 flood event in the Weber River, portions of the dike system in the Ogden Bay WMA were mechanically breached to bypass the Middle Run and South Run water control structures. The desired outcome was to reduce upstream water surface elevations (Appendix B-Figure 3). Flood waters were allowed to flow unobstructed down a channel in Unit 1. After the flood waters receded, the breaches in the levee were restored back to pre-flood conditions by UDWR.

Picture 1-14. Middle Run Structure 2011 Levee Breach

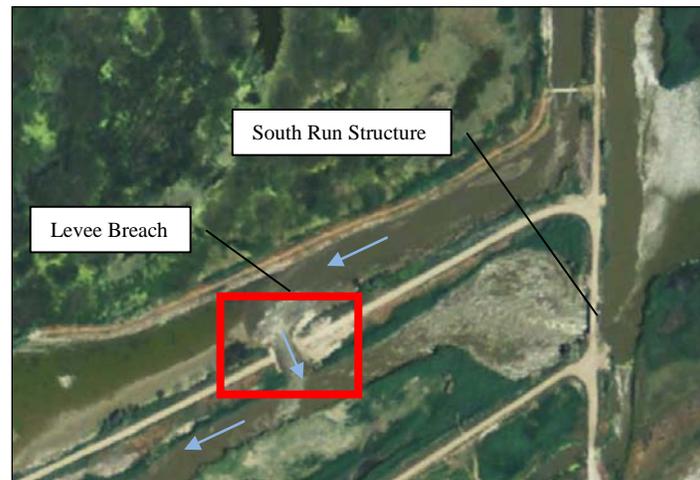
Picture 1-15. South Run Structure 2011 Levee Breach

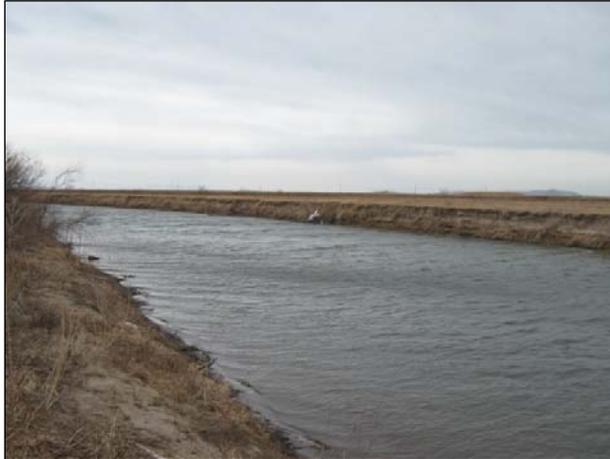
Picture 1-16. Lower Weber River Channel and Banks Looking Downstream on Private Land

these embankments and spill into the adjacent land. The following photographs depict the typical land conditions in the floodplain adjacent to the Lower Weber River.

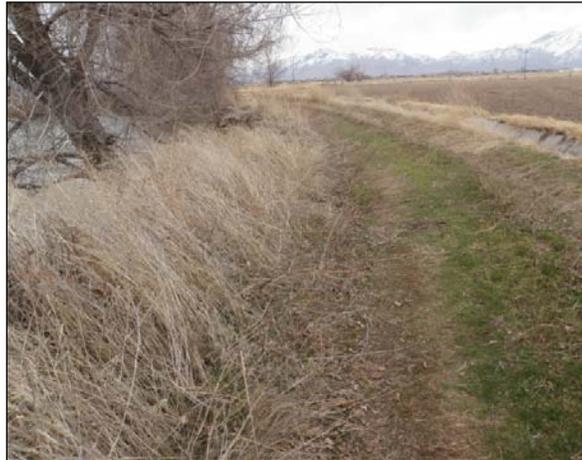
Picture 1-17. Lower Weber River Bank Adjacent to Agricultural Field

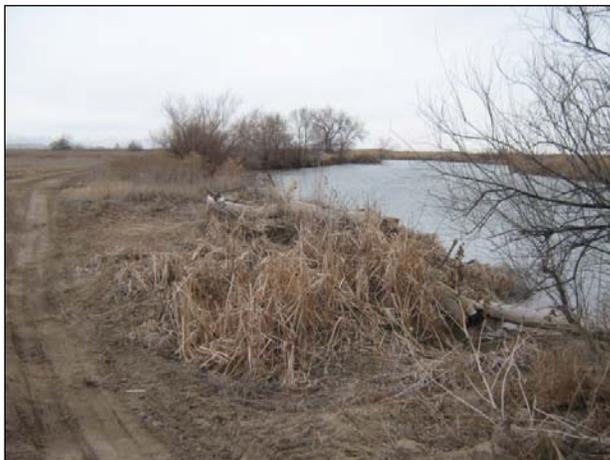
Picture 1-18. Lower Weber River Channel and Banks on Ogden Bay WMA

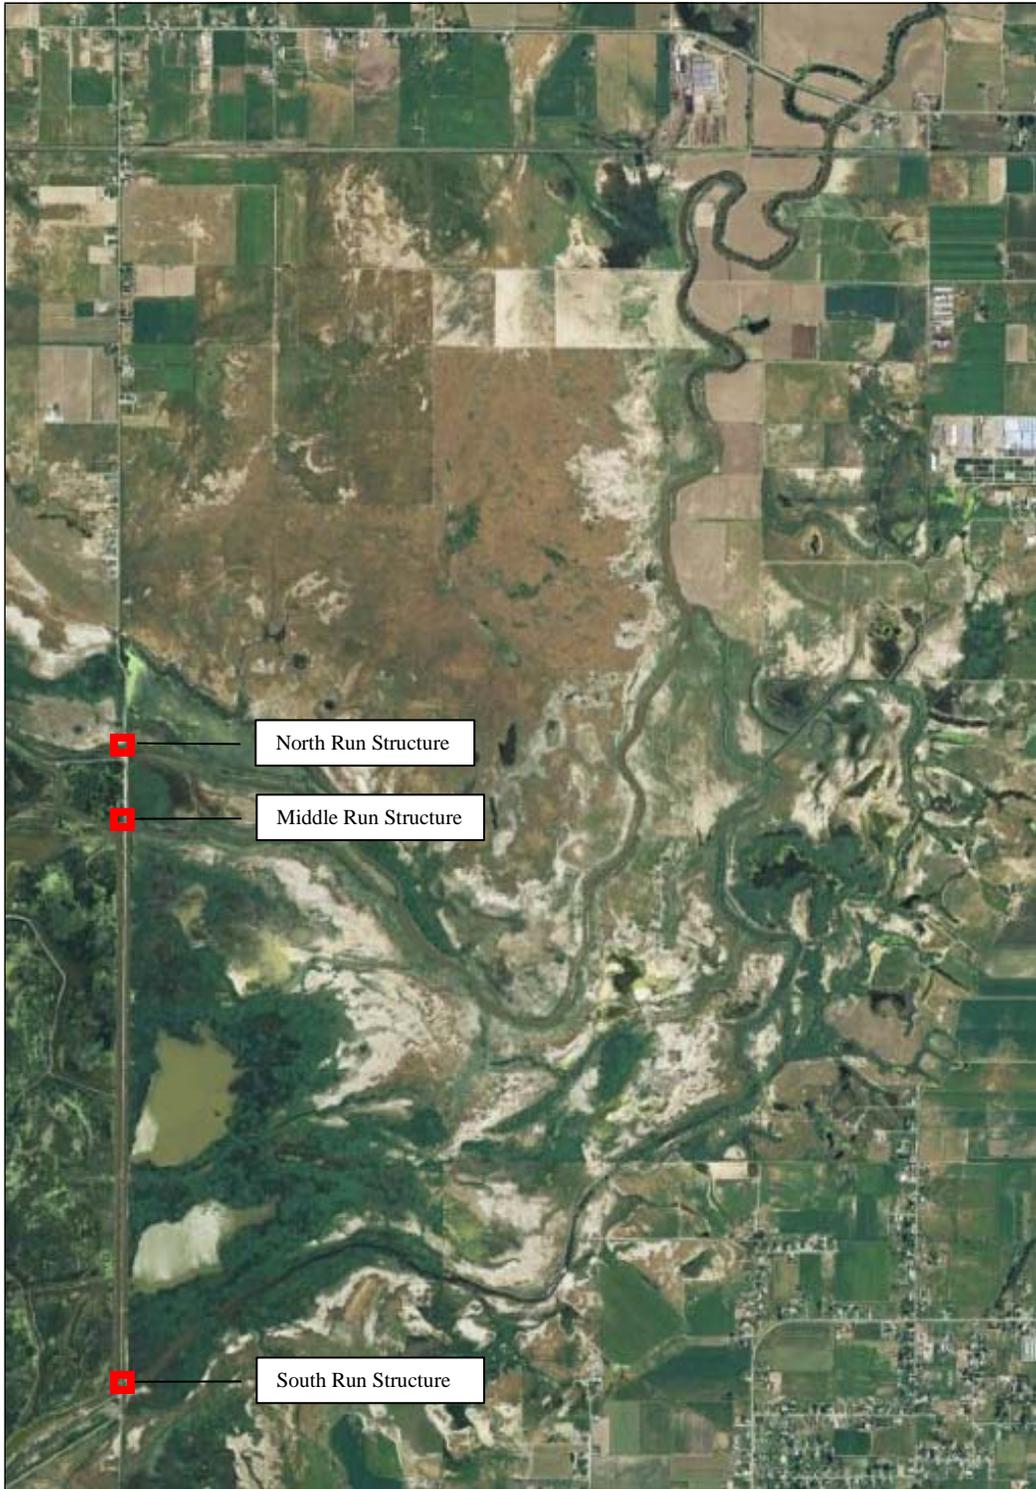
Picture 1-21. 2011 (Post-Flood) Aerial Photograph

The following historical aerial photographs (Pictures 1-19 through 1-21) show the changes in the lower Weber River channel alignment starting in 1855 to 2011.

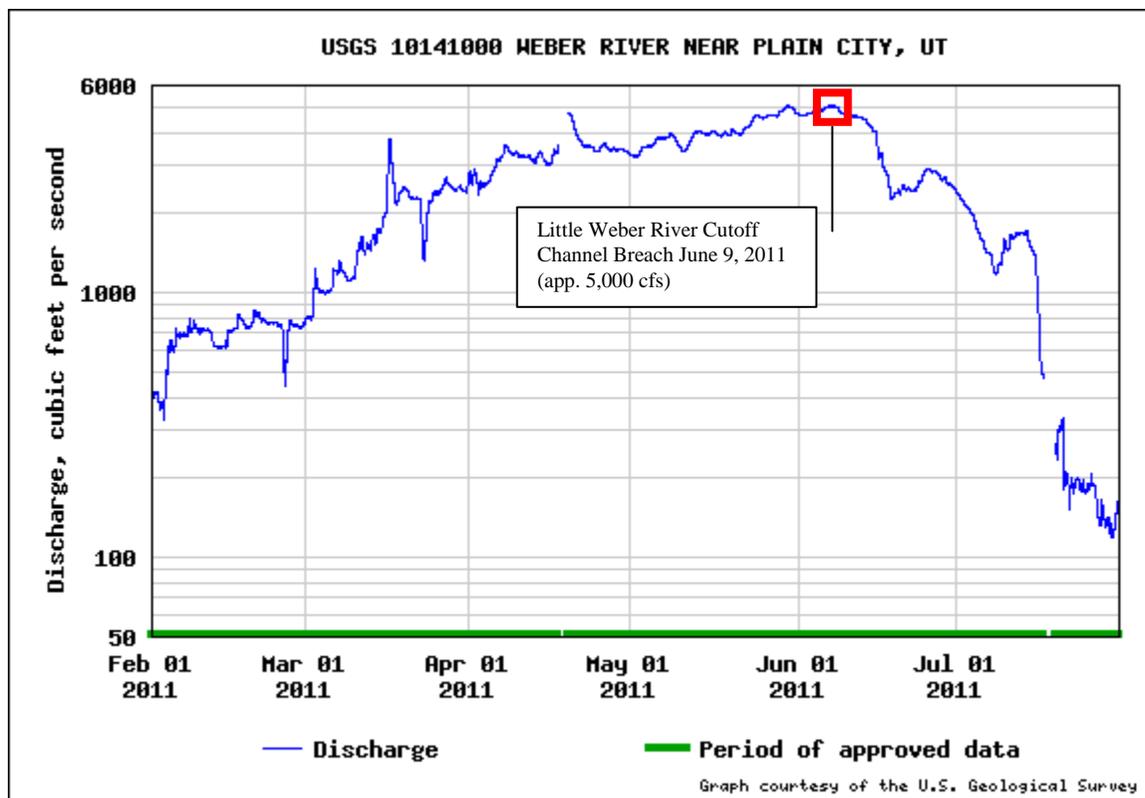
The Weber River watershed is part of the Lower Weber Hydrologic Unit 16020102. The estimated watershed area at the South Run structure is 2,110 square miles as depicted on Appendix B-Figure 2. Based on measurements taken at the USGS Plain City Gage (10141000) on the Weber River, the Weber River was observed to be above the bankfull capacity (3,500 cfs) from early April 2011 through mid June 2011 as depicted in Picture 2-1.

Picture 2-1. 2011 Discharges at Weber River USGS Stream Gage (10141000)
