United States Department of Agriculture
Natural Resources Conservation Service

**Final Environmental Assessment
for the Little Snake River Restoration Project**

July 2013

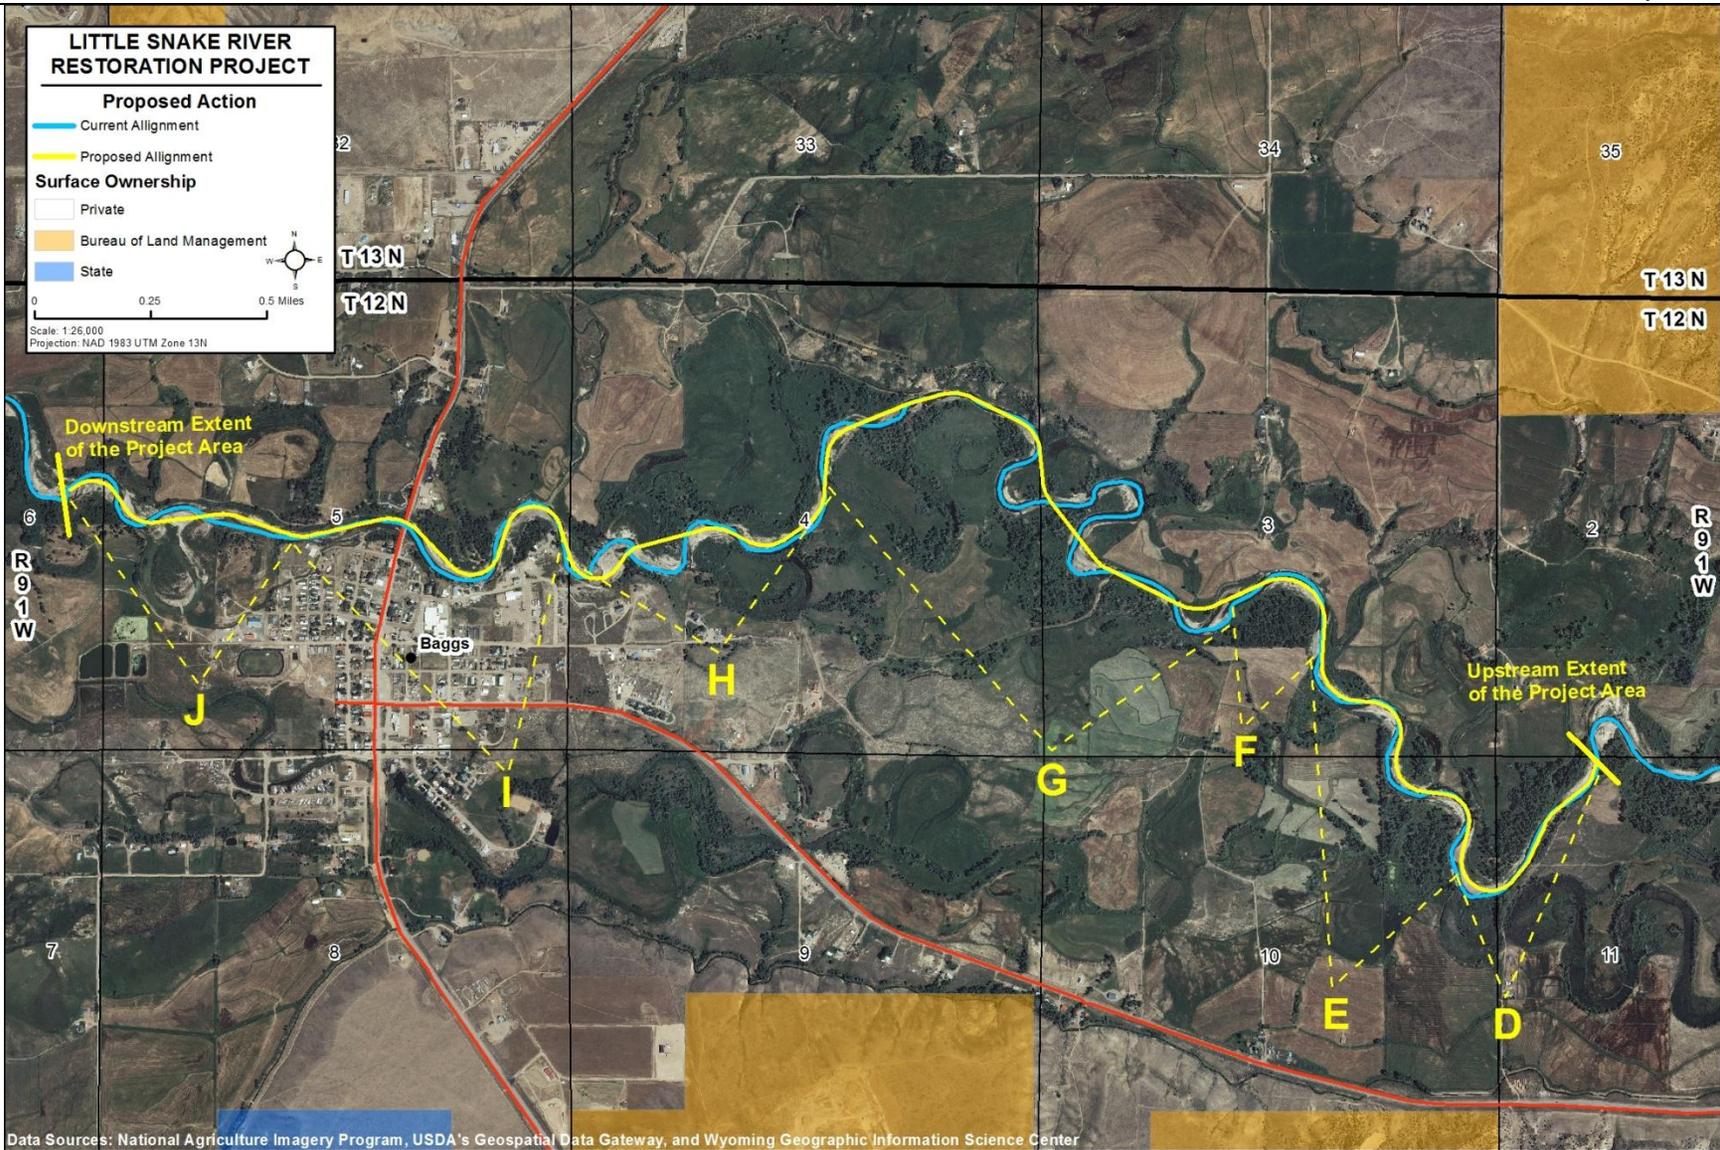
Figure 2 Project area

In total, seven cross-vane rock structures would be installed. Six rock J-hook vanes would be used to reduce near-bank stresses and to create contraction scour holes for larger compound pools, and forty-one rock barbs would be installed to reduce near-bank stresses and to define the thalweg in stream bend locations. Random boulder clusters would be located at each constructed glide/riffle bar feature. The installation of boulder clusters would be unique at each location, and are proposed to assist with grade control and an increase in aquatic habitat. In addition, in order to prevent further erosion from occurring, existing rock riprap would be supplemented or extended at two locations.

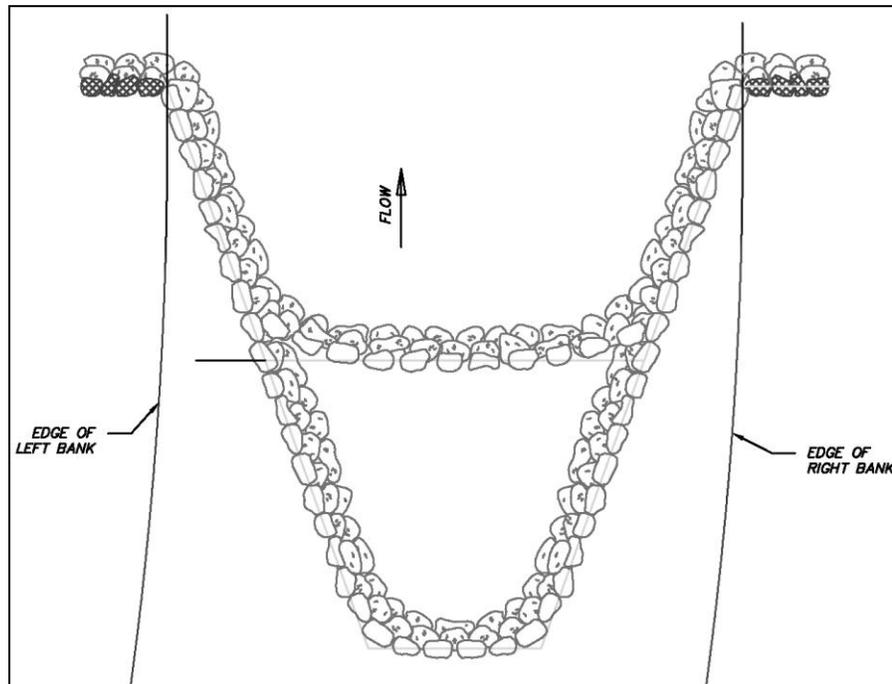
Figure 3 Typical cross-vane rock structure

The proposed structures used for diversions and grade or bank stabilization measures have been designed to allow aquatic organism passage, create habitat, and transport sediment. Cross-vane rock structures have been selected to replace existing irrigation diversions and to stabilize the riverbed and riverbank (Figure 3).

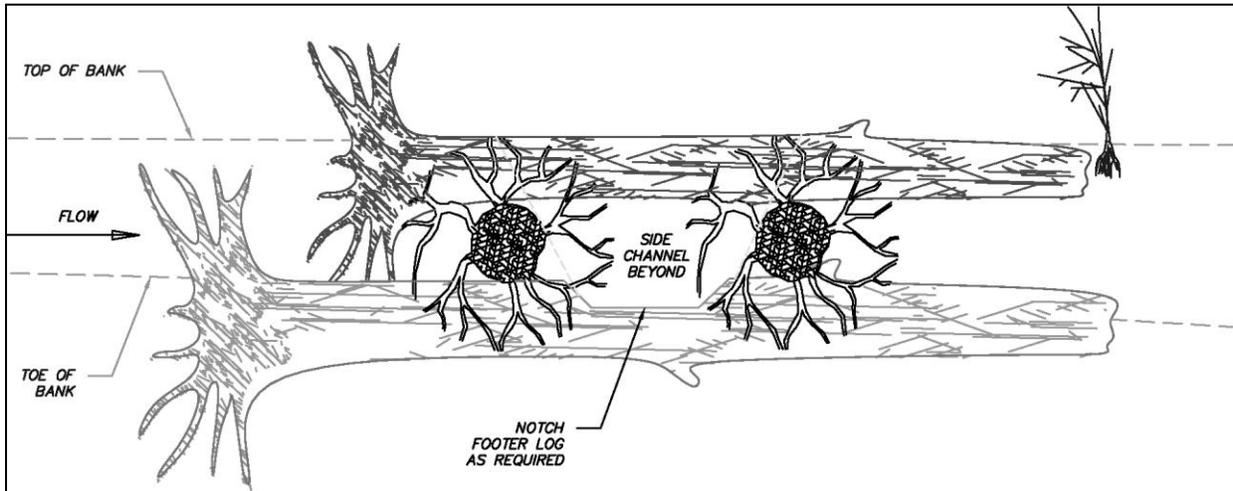
Figure 4 Typical log inlet structure

required to create a low gradient step pool channel consisting of about 90 percent pools and 10 percent step chutes. The creation of side channels would be performed concurrently with the wetlands creation described below. Side channels have been designed to carry flow nearly all year long with provisions to accommodate flood flows. Log sills in the main channel floodplain would be utilized to reduce inflow during flood stages, and rock sills would be incorporated into the low flow step chutes to maintain the constructed side channel. Additionally, two log inlet structures proposed at the entrance to the side channels would be used to limit flow during rising and receding stages of the main channel (Figure 4).

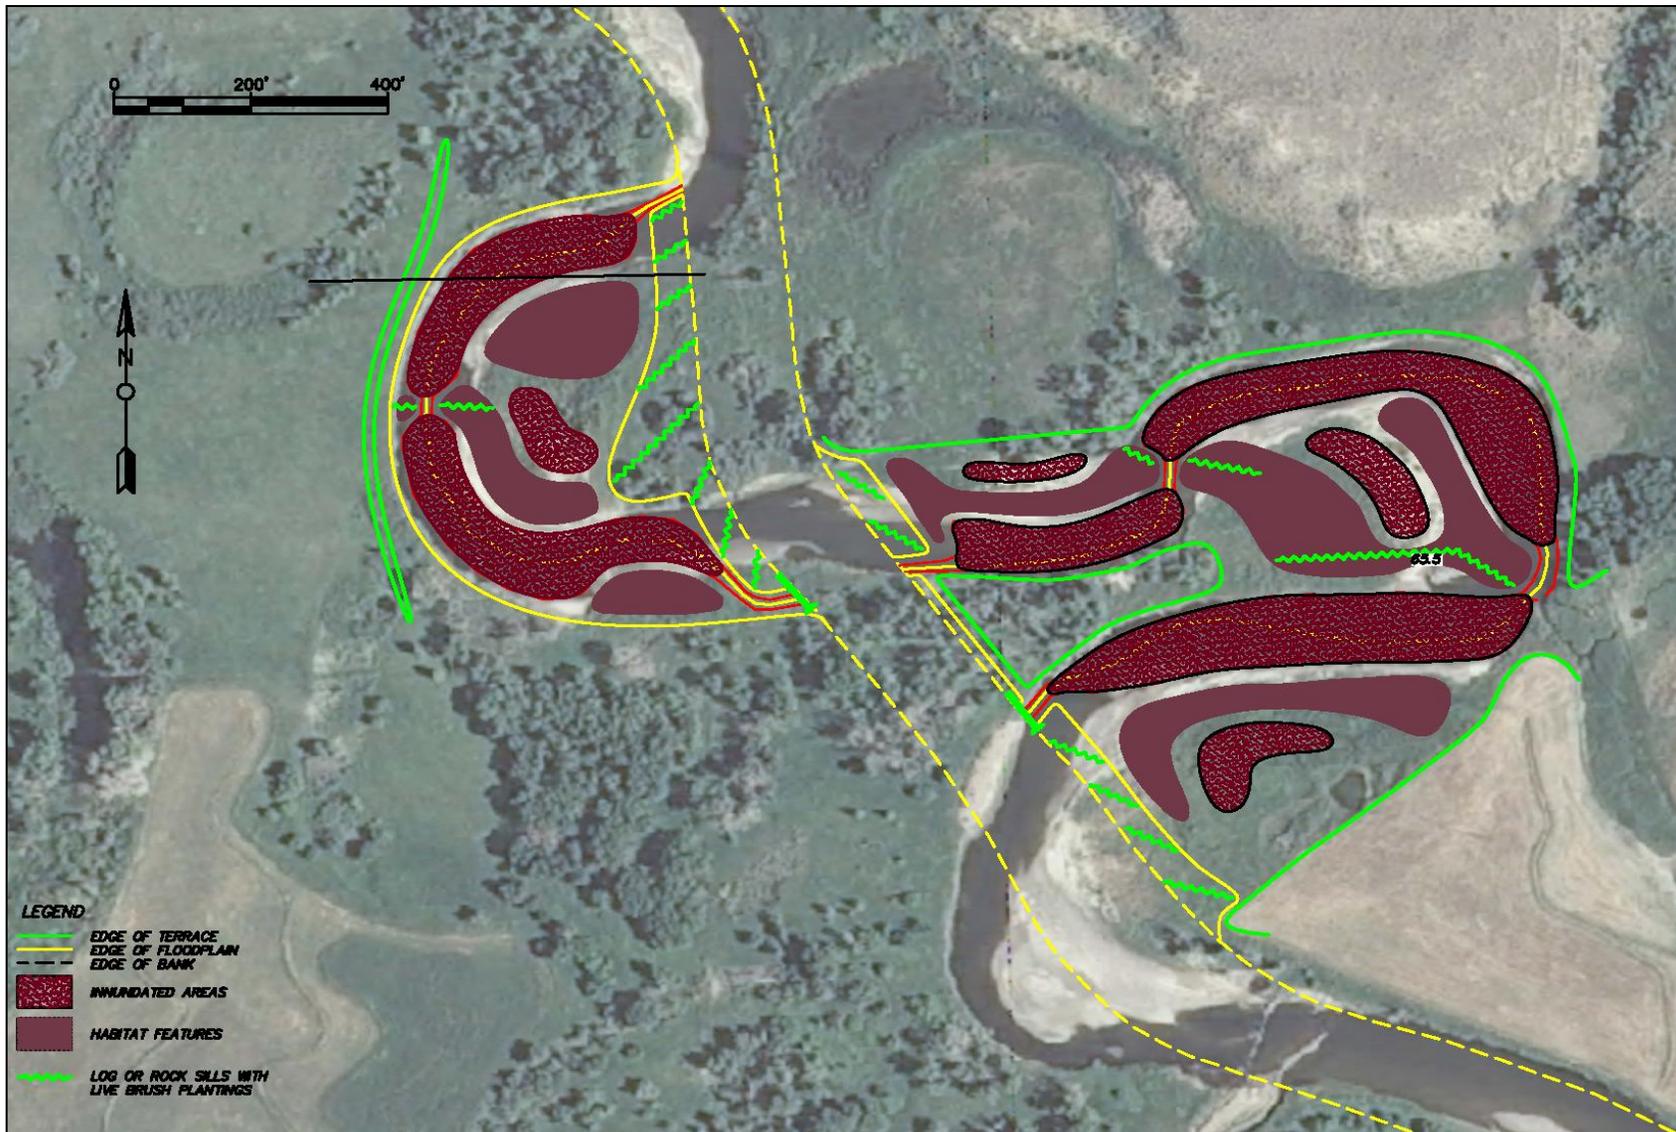
Figure 5 Side channels and two larger wetland areas proposed

Wetland habitat would be increased in total number of acres, and existing wetlands would be enhanced through improved hydrology and diversification of existing wetland types. Under this alternative, two larger wetlands would be created at the same time as and adjacent to proposed side channels, and six oxbow wetlands would also be created (Figure 5). Restored wetland features will be constructed parallel to the main river channel, thus lowering the value of these areas as nursery habitat for non-native fish species (Hill 2004).

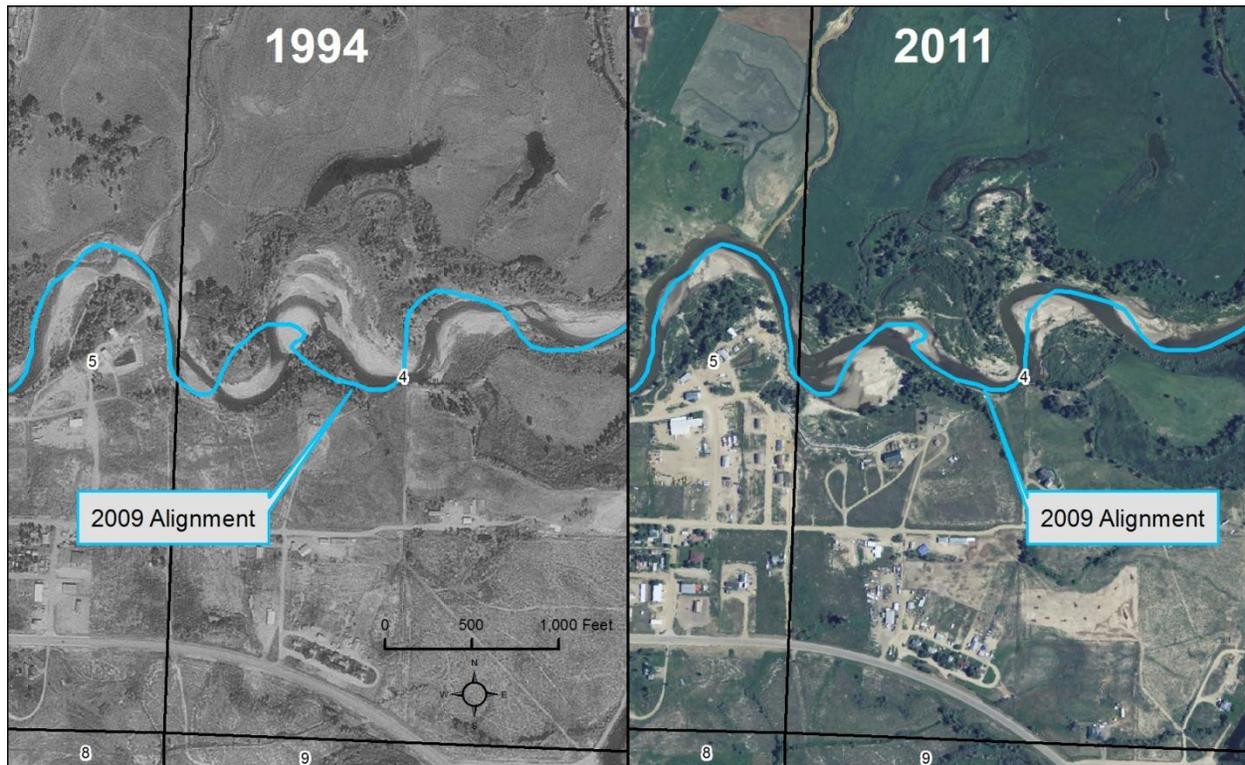
Figure 6 Year 1994, 2009, and 2011 channel alignment along a section of the project area

In the years since the flood of 1984, and including the flood of 2011, hay and croplands have suffered damage and irrigated pasture loss due to accelerated lateral migration and subsequent flooding. This has negatively impacted local ranchers and farmers within the project area. Figure 6 compares the channel position for year 1994, year 2009, and year 2011 along a section of the project area. Excessive silt transported into irrigation ditches and canals necessitates silt removal in these structures for conveyance

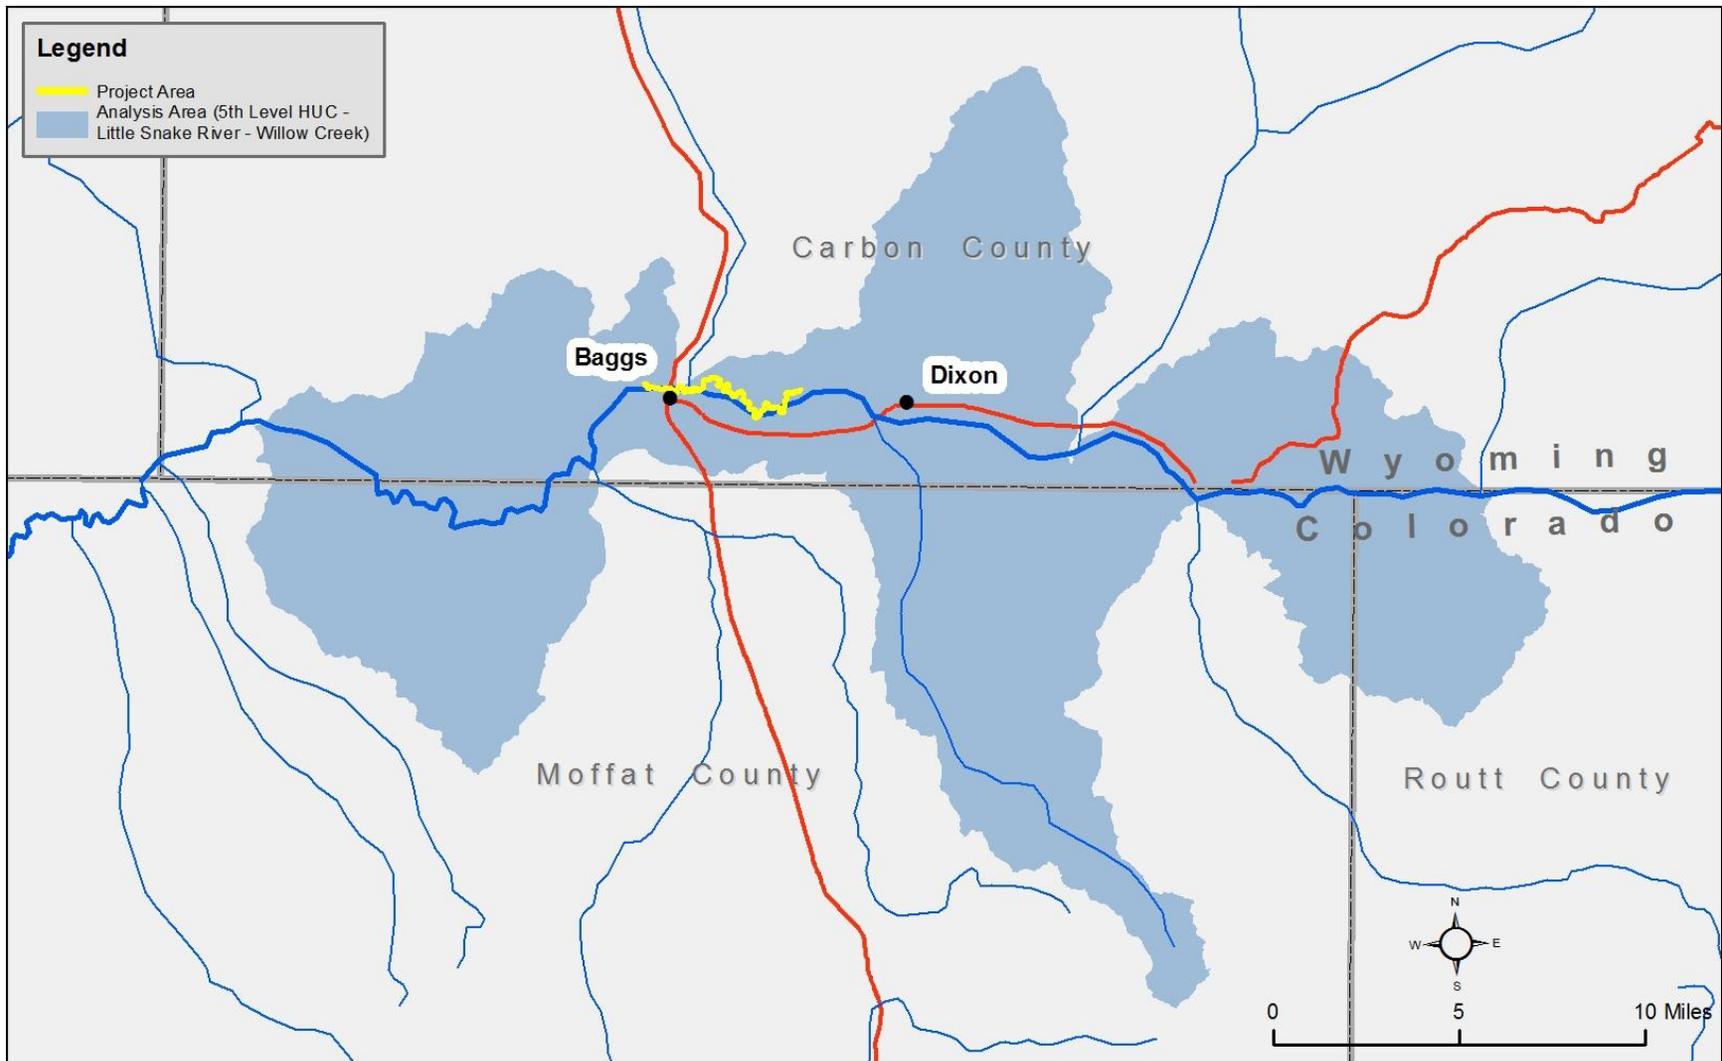
Figure 7 Little Snake River-Willow Creek watershed

Analysis Area: The analysis area for water resources is the Little Snake River-Willow Creek watershed (Figure 7).

Land use in the basin consists of approximately 25 percent forest, 70 percent range, and 5 percent agricultural. Water bodies and urban land use are estimated to comprise less than one percent for the basin. Land ownership in the watershed is a mixture of federal, state and private and land ownership in the project area is entirely private.

Only one large water storage reservoir is located within the basin and is known as High Savery Reservoir. The reservoir has a catchment basin that constitutes about 10 percent of the Little Snake hydrologic unit above the project reach. Regulated releases from the reservoir consist of a minimum discharge of 12 CFS continually for aquatic resources and up to 200 CFS during high irrigation demands (Little Snake River Conservation District).

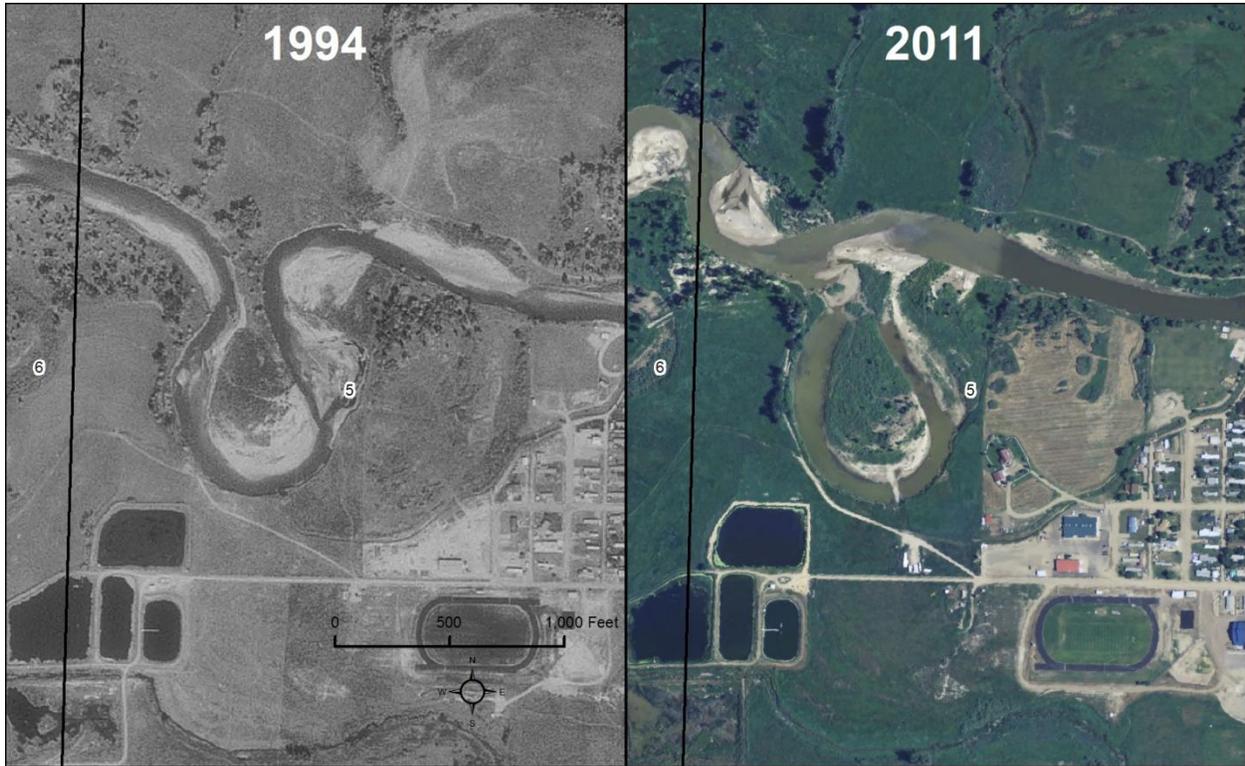
Figure 8 Meander in 1994 and 2011

The impaired condition of the river has numerous effects on the river corridor and the local environment. Sedimentation issues associated with the channel condition have deteriorated aquatic habitat, affected the operation and maintenance of the irrigation diversions, resulted in rehabilitation of the Baggs' water infiltration gallery, and contributed a disproportionate amount of sediment to the reach and further downstream. The bank erosion problems are resulting in the loss of riparian zones, agricultural lands, and aquatic and wildlife habitat. Moreover, the predicted annual sediment supply contribution from bank erosion throughout the reach currently exceeds the sediment transport capacity of the river. In addition, areas of the reach which have incised due to neck or chute cutoffs are abandoning the active floodplain and losing connectivity with the riparian corridor (Figure 8).

The cutoff process taking place in the reach is caused by reduced sediment transport, resulting in excess sediment deposition, accelerated outside bank erosion, and a destabilized system (Figure 8). As oxbows are cut off in the destabilized river section, entrenchment (vertical containment) ensues. Over time, due to ongoing entrenchment, the oxbows become perched and lose hydraulic connectivity with the river channel, which results in diminished habitat for avian and aquatic species.

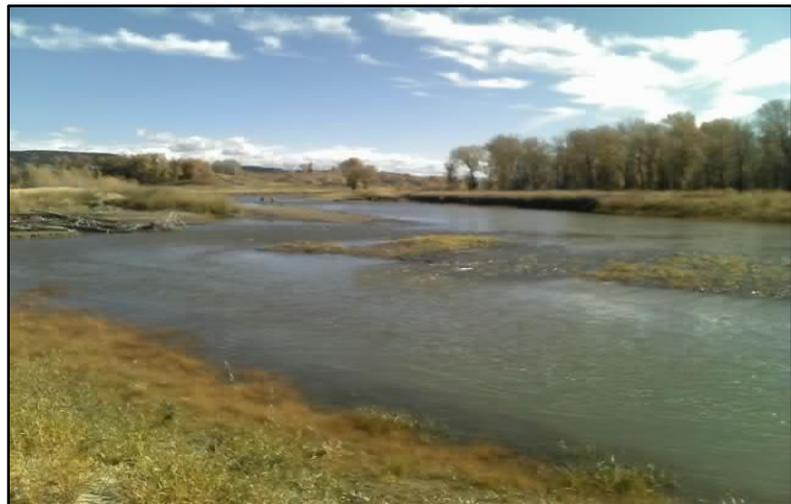
Figure 9 Sediment accumulation above Adams Diversion

The existing diversion consists of steel pipe piling spaced across the channel to accommodate installation of flashboards. However, some of the steel piling is gone and the diversion is now achieved by annually constructing a gravel dam across the channel. The diversion is regulated by a 36-inch diameter slide gate attached to a timber plank headwall. The gate and wall are located about 100 feet from the left bank of the channel.

Backwater effects from the original diversion structure have caused considerable sediment accumulation upstream resulting in a high width-to-depth ratio and bar-braided channel through the deposition (Figure 9). Currently, the sand and gravel materials dredged and placed in the diversion dam provide a local increase in the sediment supply which deposits in the channel downstream. The diversion is contributing to localized

sedimentation impacts and impairing the physical and ecological functions of the river channel.

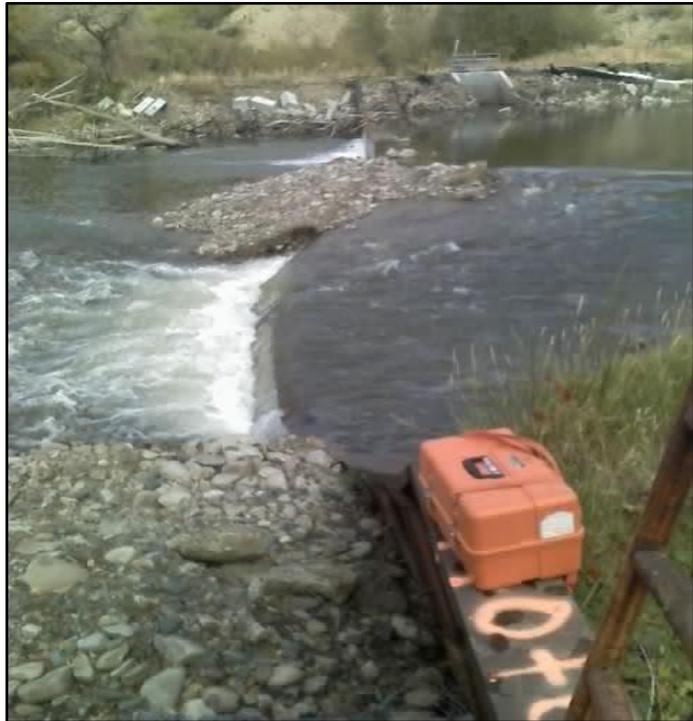
The structure consists of a channel spanning weir with a 40 feet wide by 4 feet deep notch to allow sediment transport during high flows. The weir is constructed with corrugated interlocking sheet piling and metal assemblages in the notch to allow placement of flashboards during irrigation season. For several years now, the notch in the weir has not been functional enough to allow for placement of the flashboards and consequently, the notch has been modified with a permanent plug (Figure 10). The diversion is regulated by a slide gate attached to a concrete inlet structure with a trash guard. The diversion inlet is in excellent condition and located on the right bank of the channel.

Figure 10 Baggs Diversion with plugged notch, damaged weir crest, and gravel dam

Historically, the Baggs Diversion has been a seasonal barrier to fish migration. Owing to recent operations and maintenance modifications, the structure has become a permanent fish barrier and has impacted sediment transport characteristics. Additionally, further damage to the weir has occurred due to debris and sediment loads and is in a rapidly deteriorating state.

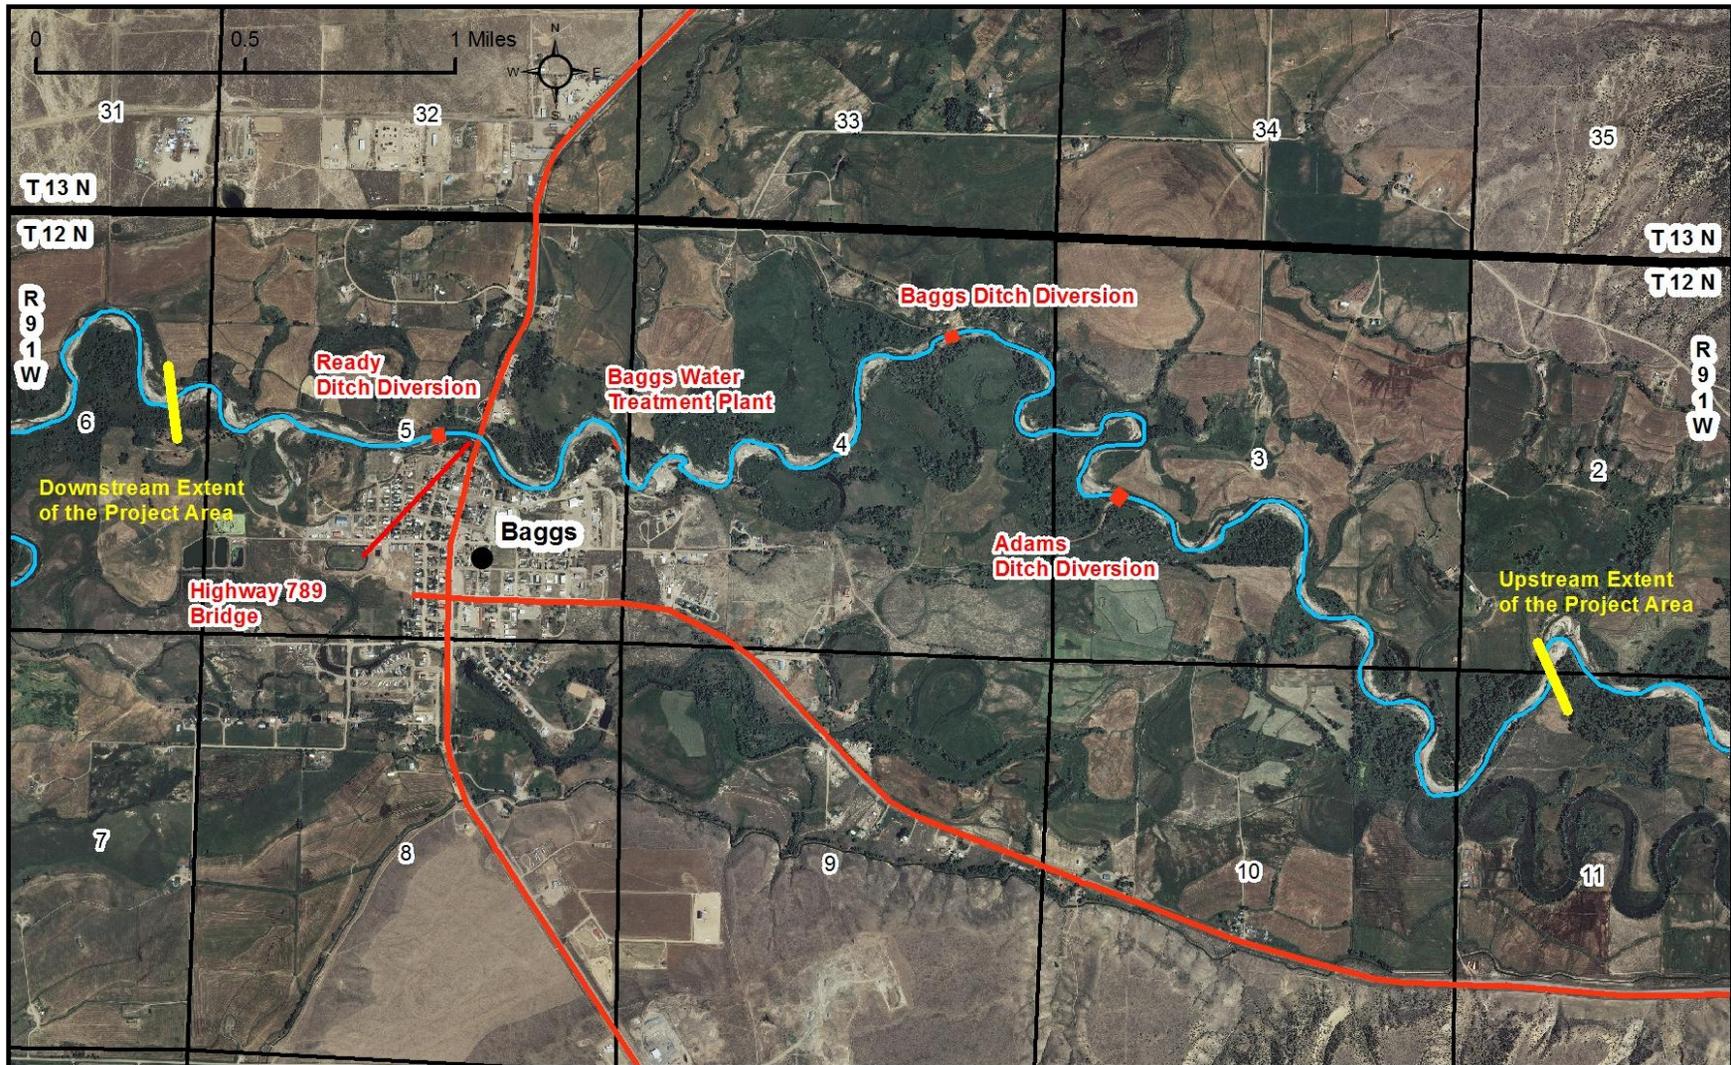
Figure 11 In-stream infrastructure

Analysis Area: The analysis area for infrastructure includes the project area and the Little Snake River-Willow Creek watershed. The in-stream infrastructure present in the project area is summarized below and depicted in Figure 11.

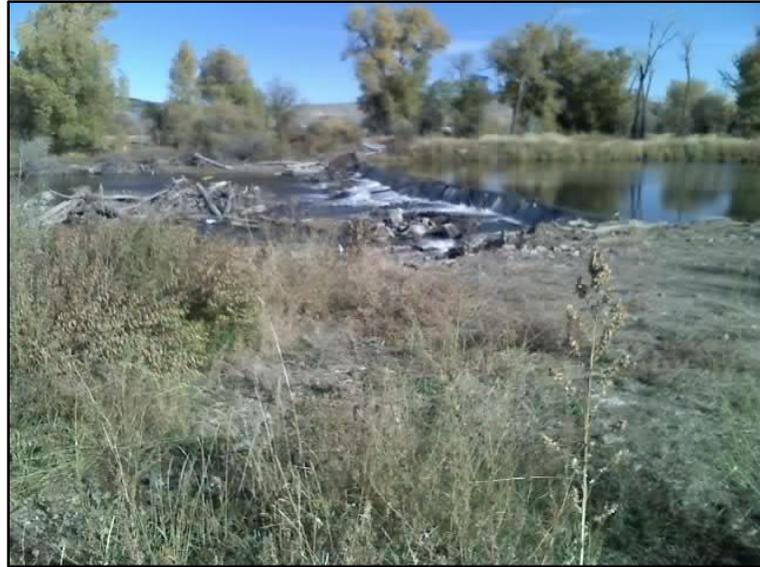
Figure 12 Ready Ditch Diversion

The diversion spans the entire channel and is constructed of miscellaneous materials (Figure 12). Steel upright components and permanent flashboards create the crest of the weir above the channel bed. The diversion is regulated by a 24-inch diameter slide gate attached to a metal frame. The gate is located about 100 feet from the left bank of the channel.

This diversion structure poses several impacts to the project area and stream corridor. The backwater effect from the weir has reduced the rivers sediment transport capacity and resulted in sediment deposition and failure of the Town of Baggs’ water infiltration gallery. In addition, flooding problems have increased through the Town of Baggs due to the backwater effects. The structure is also a major year-round barrier to fish migration.

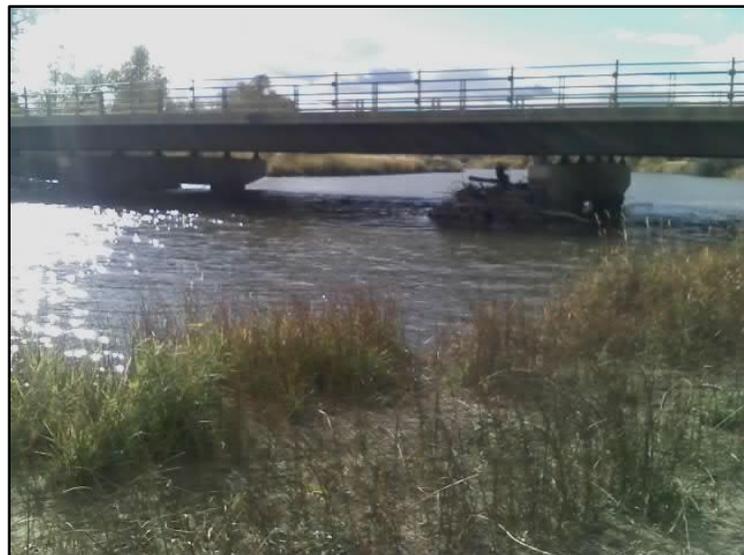
Figure 13 State Highway 789 Bridge

The bridge foundation includes several concrete piers in the active channel and armored abutments on both banks. Currently, the approaching road embankments confine the floodplain. The structure frequently accumulates debris at the pier caps and periodically has trapped large woody debris along the deck stringers during high flows resulting in emergency maintenance efforts (Figure 13).

Apparently the orientation of the bridge was originally constructed to be fairly perpendicular to the channel, although lateral migration of the channel has skewed the flow approach angle to roughly 45 degrees. However, the bridge is not on the state highway department's list of scour sensitive bridges

Additional cross-vane rock structures are included in the proposed action at the Highway 789 Bridge crossing to direct woody debris through the piers in order to reduce accumulations and flooding risks. This will allow for greater passage of large woody debris and floating trees under the bridge, thereby reducing debris damage that threatens the bridge and results in emergency closure and debris clearing operations during high water. In 1997, an ice dam also piled up against the bridge piers causing minor flooding in the Town of Baggs. Changes in flow orientation (thalweg), increased velocity, and channel morphology should remediate these problems in the future.

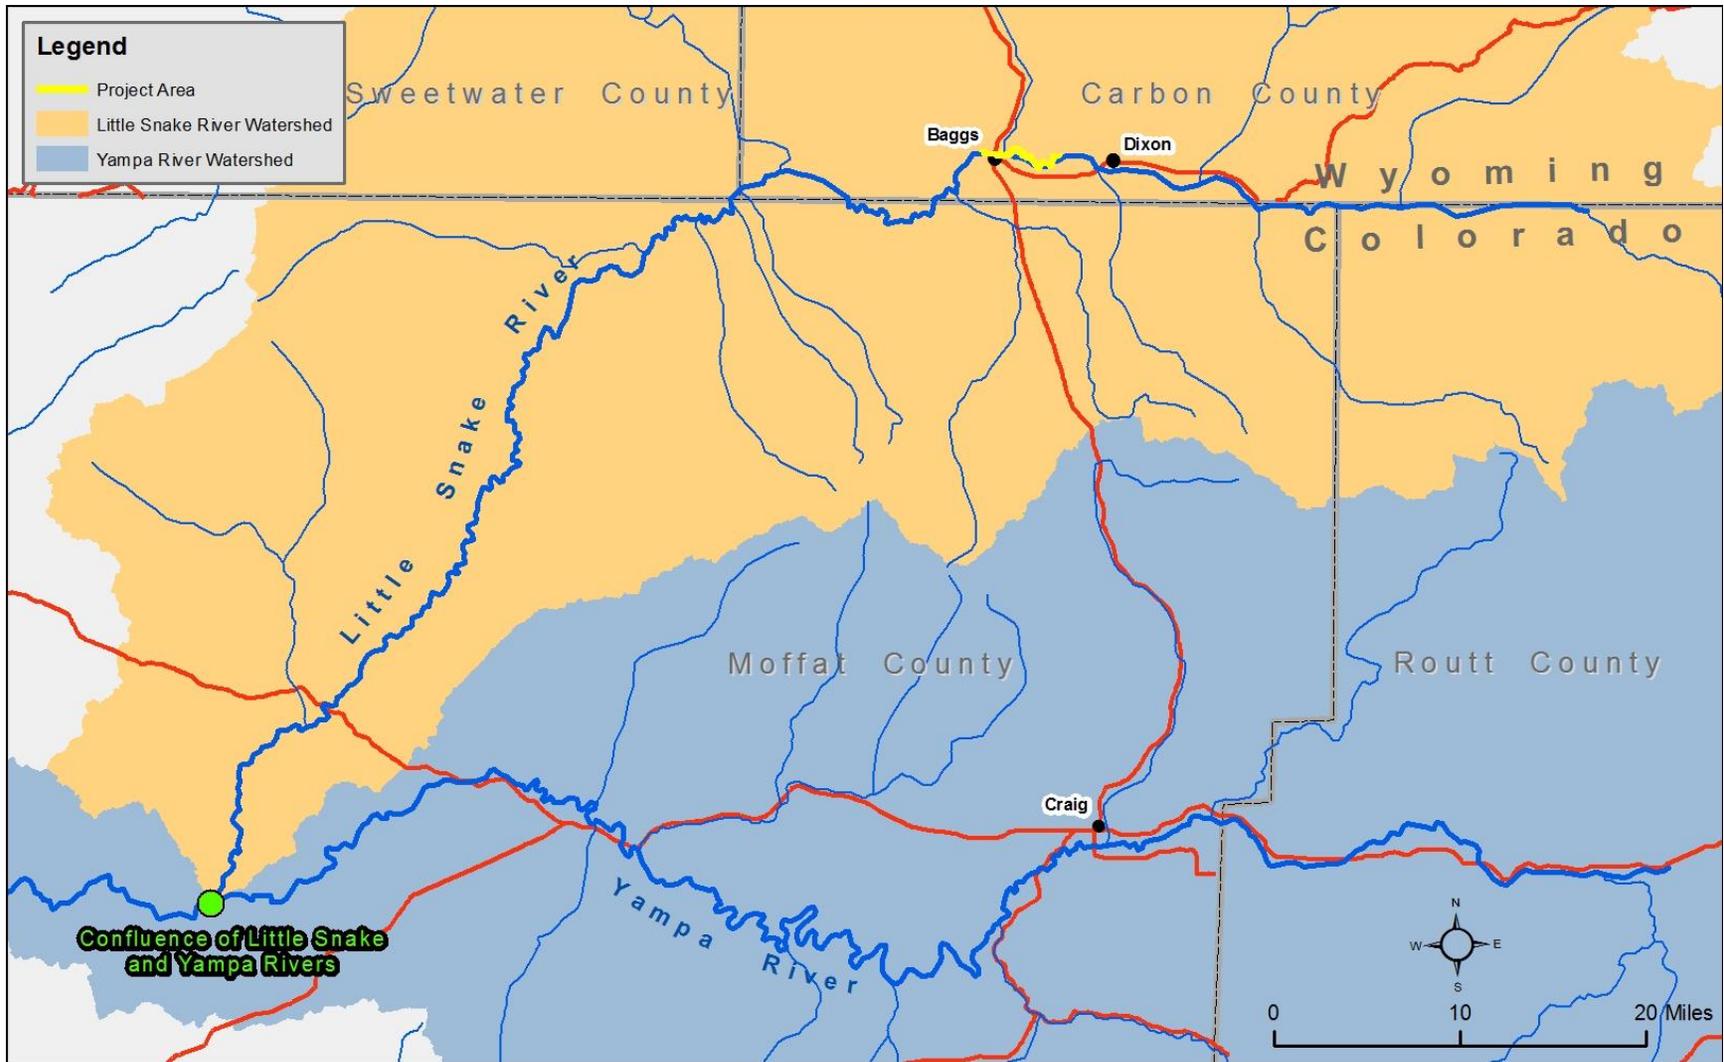
Figure 14 Confluence of Little Snake and Yampa Rivers

The Little Snake River provides approximately 28 percent of the Yampa River's flow and 60 percent of the Yampa River's sediment supply (Figure 14). The Yampa River Management Plan and Environmental Assessment (Roehm 2004) identified the flow contribution of the Little Snake River as important to the recovery of the Yampa River. Flows from the upper Yampa River, especially spring peak flows, were crucial to the maintenance of the Green River's “large-river” characteristics and, therefore, very important to maintaining suitable conditions in the Green River downstream of the confluence (Holden 1980). The sediment supply of the Little Snake River is also believed to be important to the maintenance of backwater nursery areas utilized by young Colorado pikeminnow in the Green River (Smith and Green 1991).

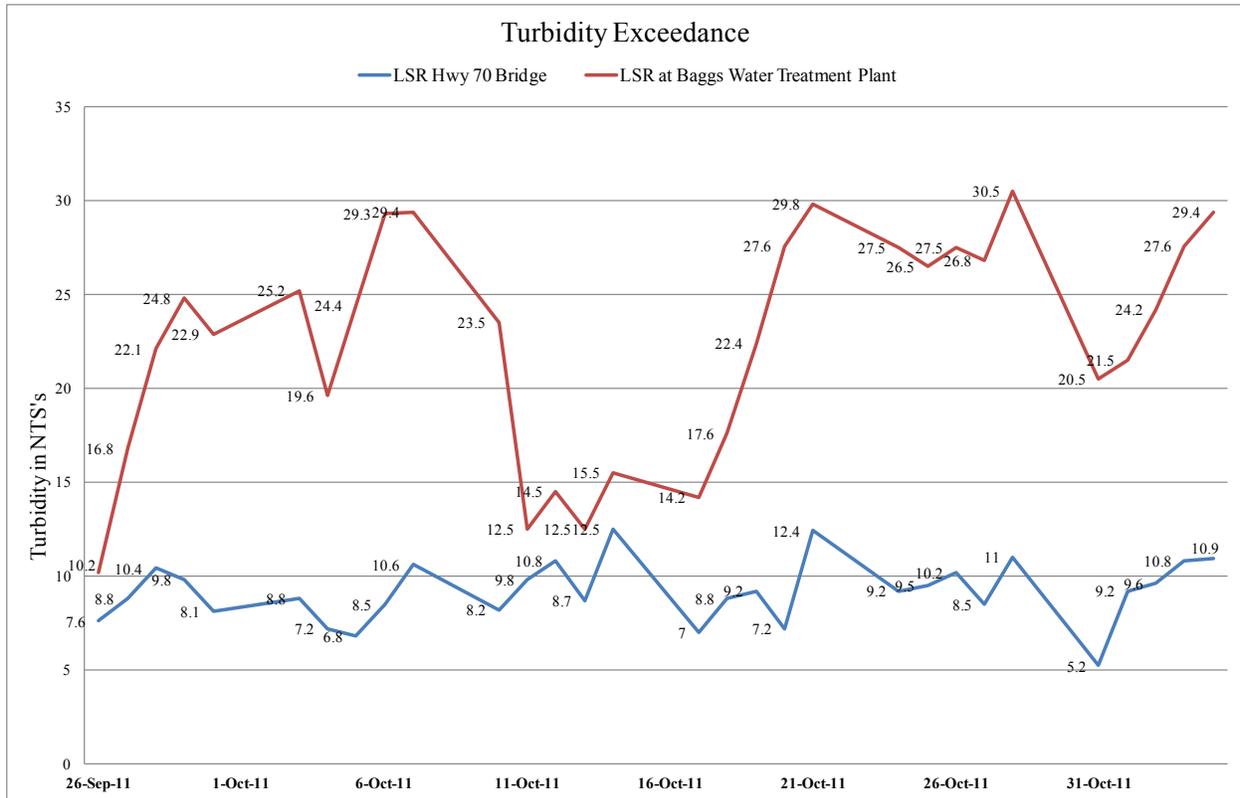
Figure 16 Temporary turbidity increases during 2011

As part of the Clean Water Act (CWA) Section 404 permit for this project, the Wyoming Department of Environmental Quality (WDEQ) issued a CWA Section 401 water quality certification. In September 2011, the LSRCDC received a temporary increase in turbidity waiver from the WDEQ for the Little Snake River while previous river work was taking place (restoration work was completed upstream of the project area). The WDEQ authorized the LSRCDC to exceed the turbidity standard for 30 days. Section 23 (a) of Chapter 1 of the WDEQ Water Rules and Regulations states, “~~I~~ all cold water fisheries and drinking water supplies (classes 1, 2AB, 2A and 2B), the discharge of substance attributable to or influenced by the activities of man shall not be present in quantities which would result in a turbidity increase of more than 10 NTUs.” The data collected over the 30-day period is shown in Figure 16 (weekends were not included in the data since construction activities did not take place). While there were exceedences to the turbidity standard, there were no major impacts to the river or the Town of Baggs’ water treatment plant. It should be noted that the replacement of the town’s water treatment infiltration gallery partially overlapped with the construction upstream on the Little Snake River and this also contributed to the increase in turbidity. Turbidity associated with the planned project is expected to be less than that associated with the 2011 construction.

It is anticipated that the proposed project would create turbidity standard exceedances, and the LSRCD would again work with the Town of Baggs and the WDEQ to monitor turbidity during all construction phases. The temporal increase in turbidity would be classified as an unavoidable adverse impact of the project; however, the impact would be of short duration and would be permitted to occur by the WDEQ under the CWA.
