SOUTH JERSEY LEVEE INVENTORY

Levee 13 – Locust Island Levee at Hancocks Bridge, Salem County, New Jersey

November 2010

USDA Natural Resources Conservation Service
Assisting
New Jersey Department of Environmental Protection
Bureau of Dam Safety and Flood Control

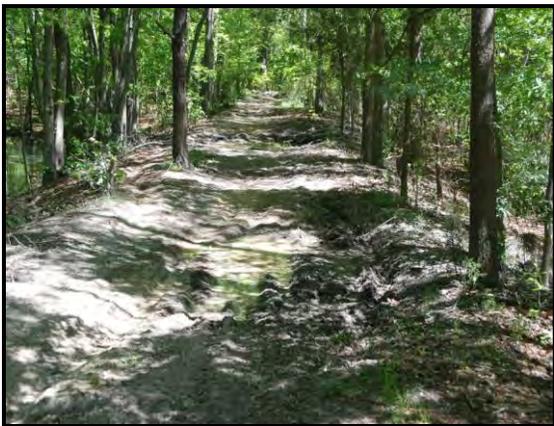
Vegetation Control

None

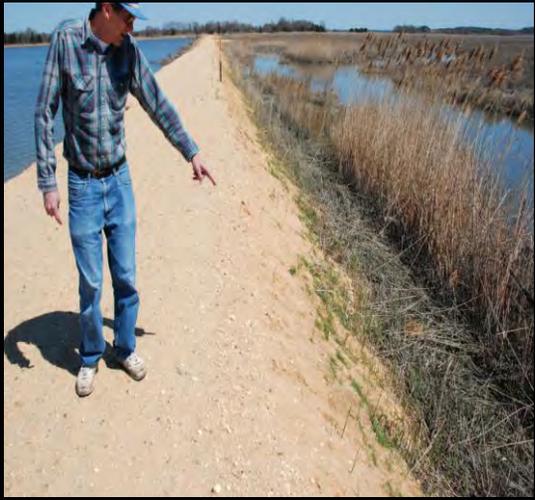
Sod Cover (Percent)

0 - 25

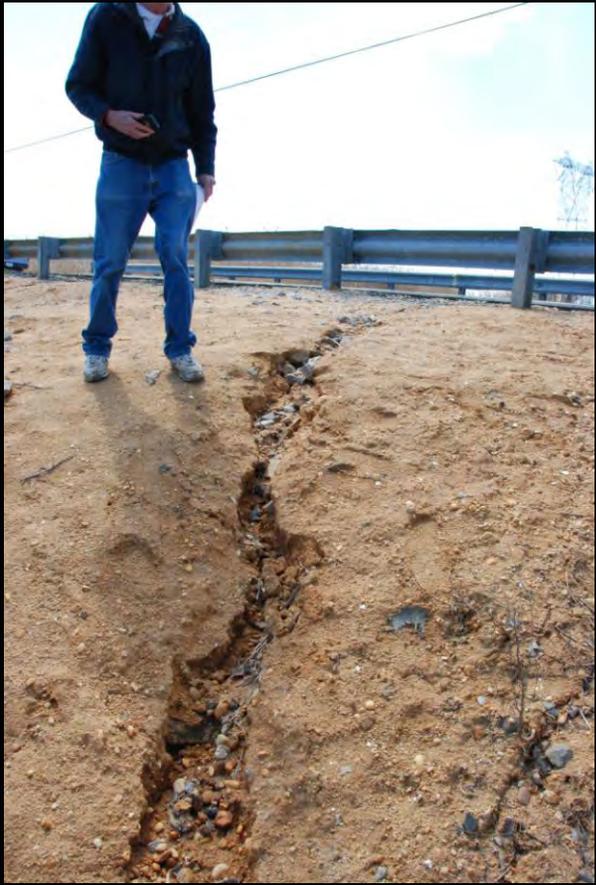
Erosion

Yes

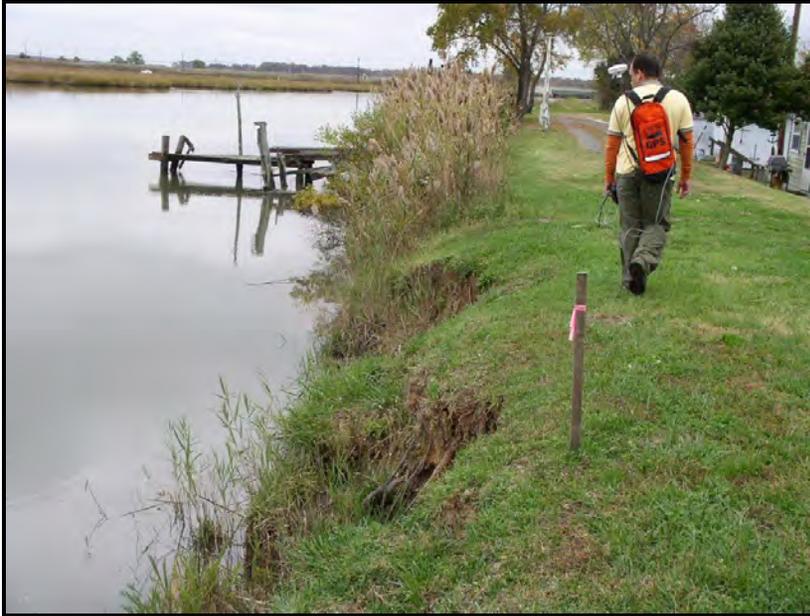
Slope Stability

No

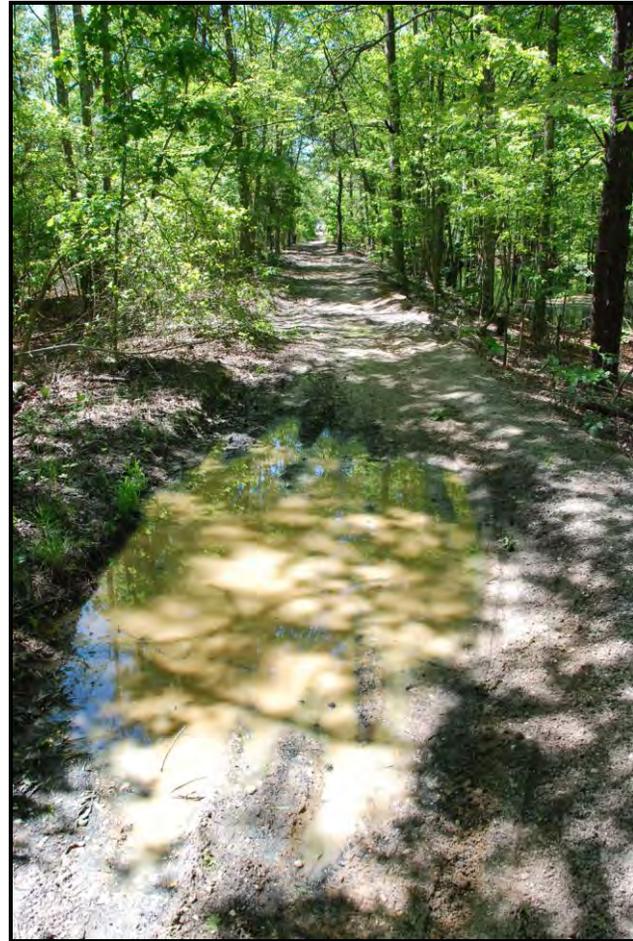
Settlement

Considerable

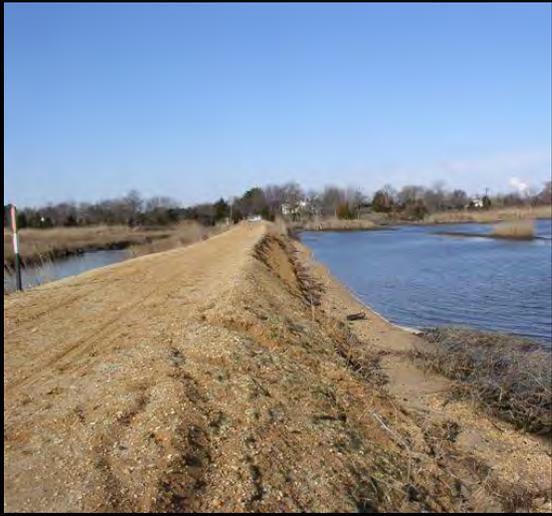
Cracking

Some

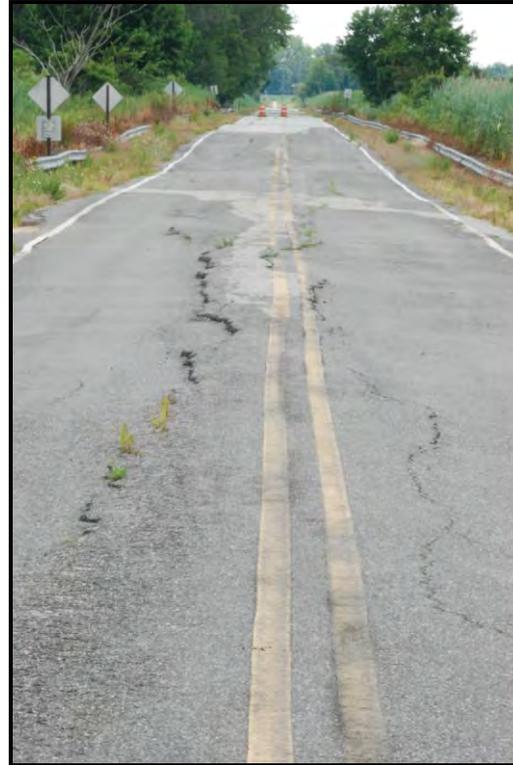
Considerable

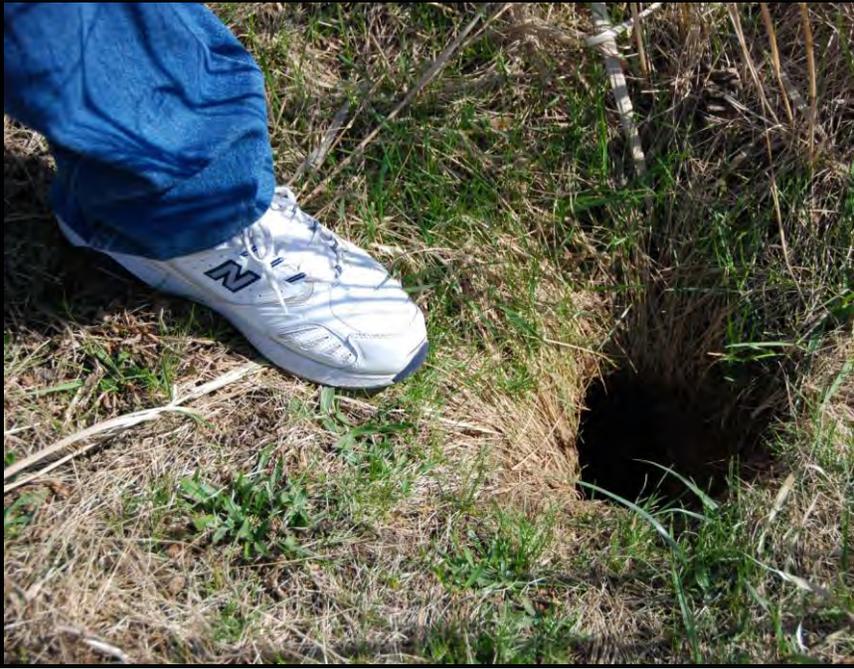
Burrowing Animal Presence

Some

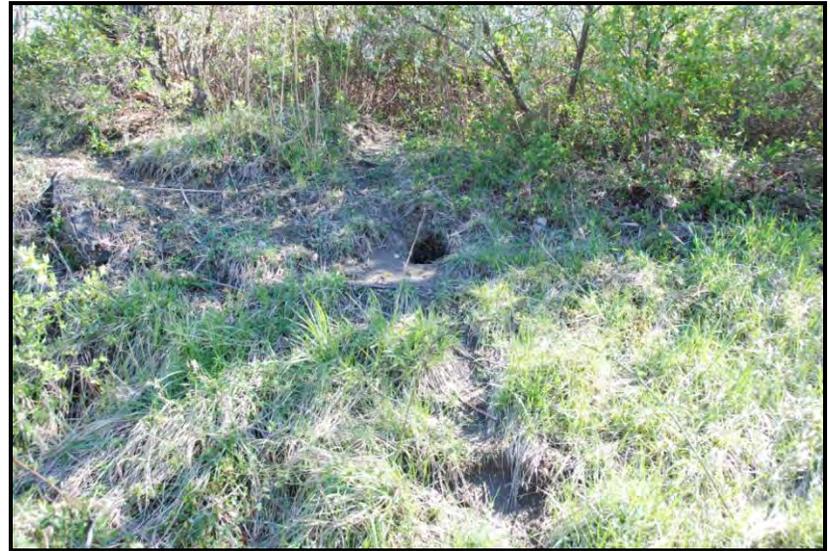
Considerable

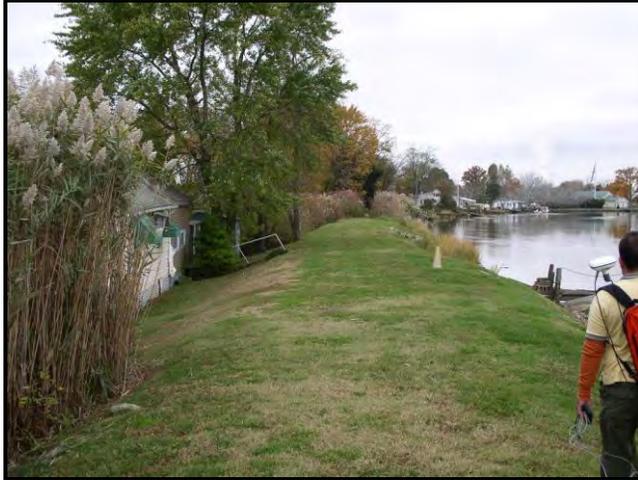
Encroachments

Some

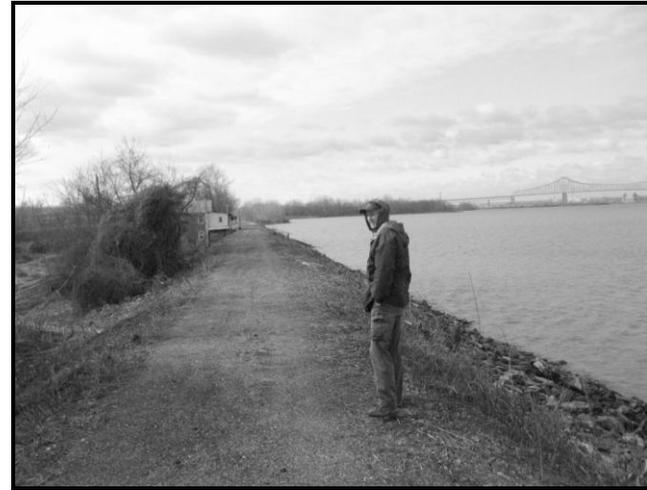
Some

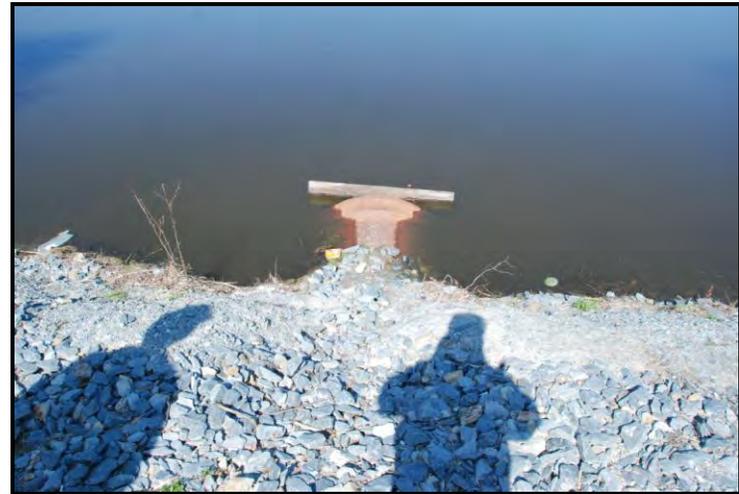
Improvised Wood Floodgate

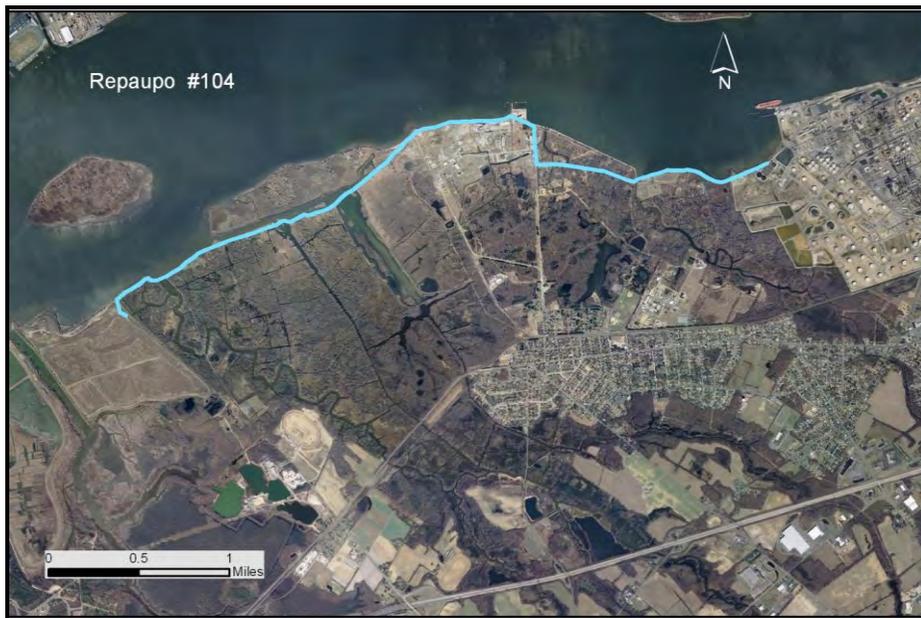
Figure 15- Levee Profile and Overview – Levee #104 Repaupo Creek (Protects Gibbstown)

(Gloucester County LiDAR data = elevations in feet (Y Axis), Mensuration line(X Axis) (Feet)= southwest to northeast)

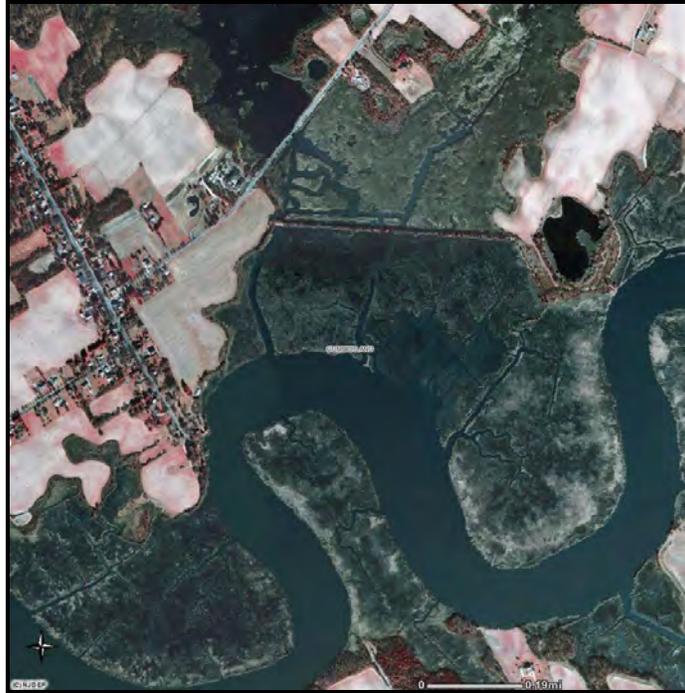
of wave action and river current, and maintenance was costly. Periodically, high tides, often associated with hurricanes, caused damage to the dike. Storms that damaged or overtopped the dike occurred in August 1933, October 1933, November 1953, August 1955, and May 1960 (USDA SCS, 1962).

Figure 26 – Mill Creek Dike at Greenwich on Cohansy River, Cumberland County – 2002
(Photo Courtesy of NJDEP I-Map)

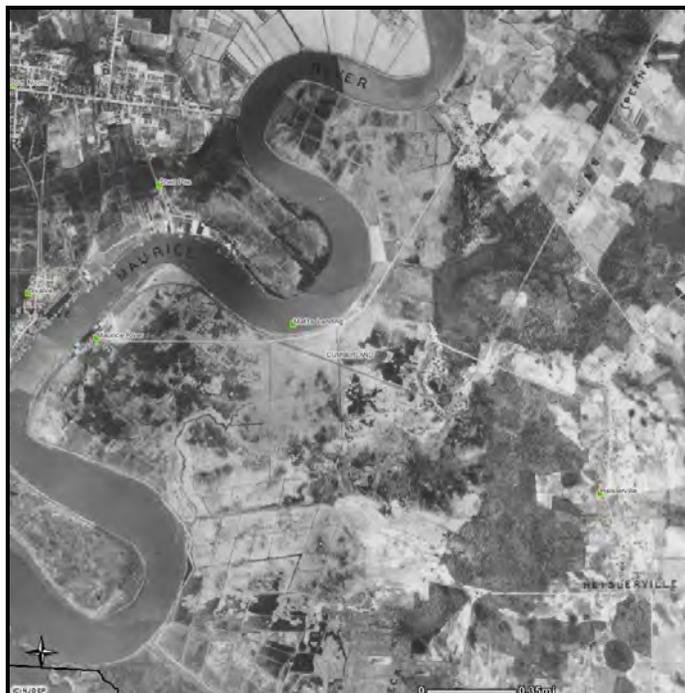
Figures 27 and 28 show the Port Norris and Heislerville levees along the Maurice River in 1930 and 2002. Note the change in the Heislerville levee over that time frame.

Figure 27 – Port Norris and Heislerville Levees, Cumberland County – 1930
(Photo Courtesy of NJDEP I-map)
